Observed Earthquake Damage to Christchurch City Council Owned Retaining Walls and the Repair Solutions Developed

ABSTRACT

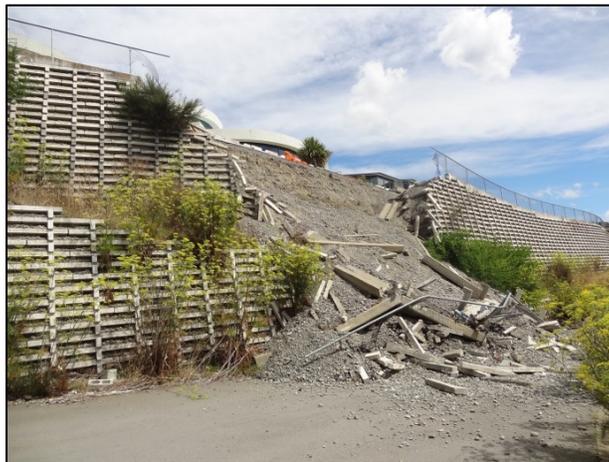
Crib walls developed a poor reputation because of the performance of some walls in the earthquakes. There is little holding the crib units together except gravity, so under vertical accelerations the crib units were able to shake apart and catastrophic collapse of these walls was not uncommon. An example is shown in Figure 1. Other walls were less damaged, but significant volumes of fill were lost from the wall and this reduced the stability of the structure as shown in Figure 2. The tendency to use rounded river run as fill for the walls was particularly detrimental because these rounded stones were easily mobilised during shaking and lost through the front of the wall.

Figure 1. An example of a collapsed crib wall

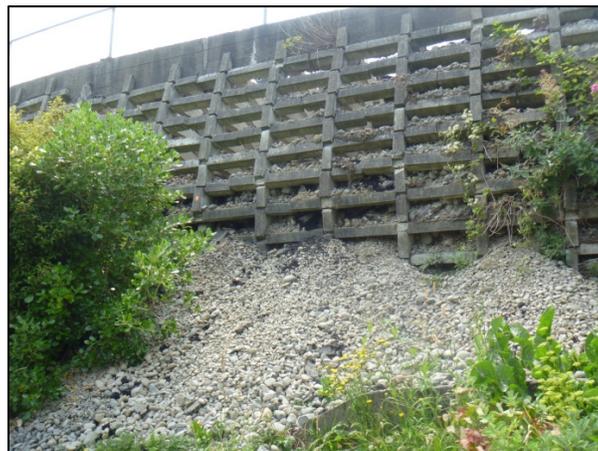
Figure 2. A crib wall showing bulging and loss of fill

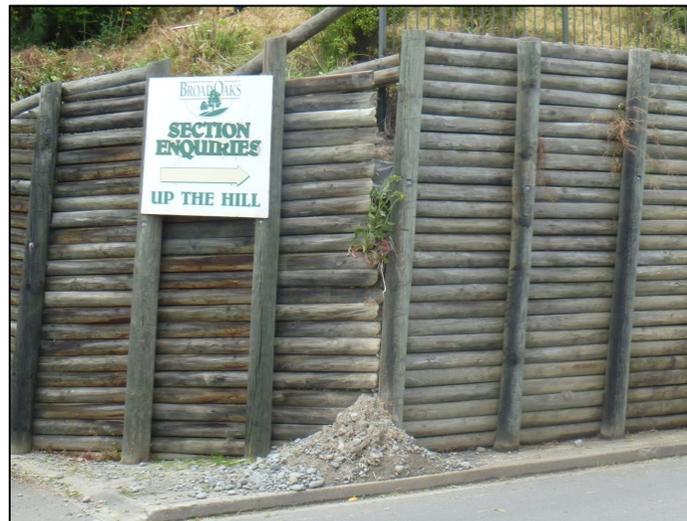
Both anchored and unanchored timber pole walls are common in Christchurch. The damage to these walls tended to be to individual elements or points of weakness. For example outside corners were often vulnerable, like the example shown in Figure 3, and lagging could pop out from behind the vertical poles. In other walls individual poles may splinter. However collapse of these walls was not routinely observed. One particular phenomenon was where anchors have small plates on the face of the timber poles and the shaking has caused the poles to move, but the anchors have remained in place. This often resulted in the anchor plate punching into the pole, as shown in Figure 4, or else the anchor head failing. Elsewhere walls may have deformed by moving forward during shaking and then the fill behind the wall has settled. This prevents the wall from returning to its original position and results in ground deformation behind the wall.

Figure 3. Damage to a vulnerable corner of a timber pole wall

Typically timber pole walls needed little repair and in some instances it was sufficient to replace damaged elements on a like for like basis. Where, for example, corner sections had been damaged additional poles or anchors were added.

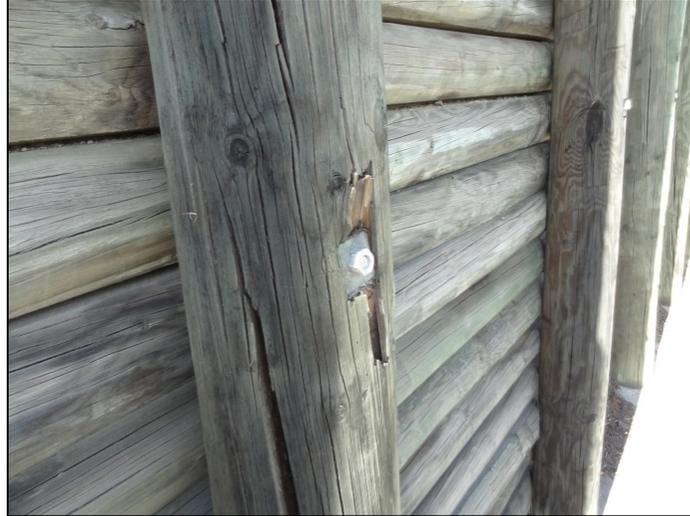
Figure 4. Damage around the anchor head of a timber pole wall

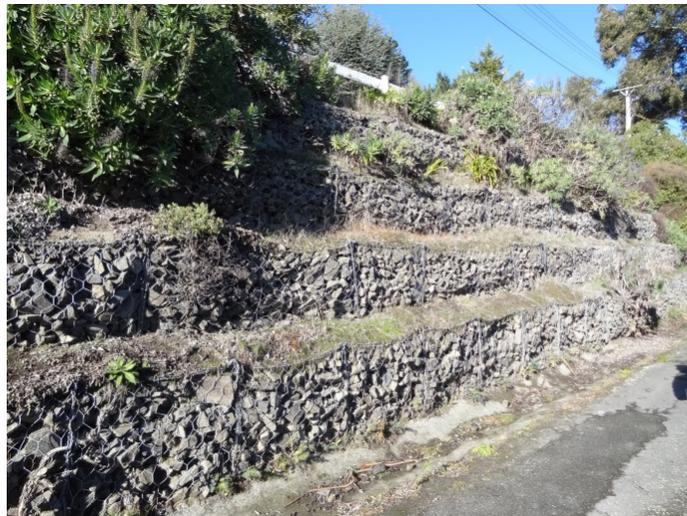
Gabion baskets are inherently flexible structures. Therefore during earthquake loading these walls tended to deform as can be seen in Figure 5. Generally baskets did not rupture and in the majority of cases the roads and infrastructure behind the walls remained serviceable, however deformation in both the wall a surface behind the wall could be considerable. Often where a road or footpath was above the wall, cracking could be observed in line with the back of the baskets. An example of this can be seen in Figure 6. Baskets filled with rounded river run or else loosely packed stone of any type often suffered greater deformation.

Figure 5. A badly deformed gabion wall

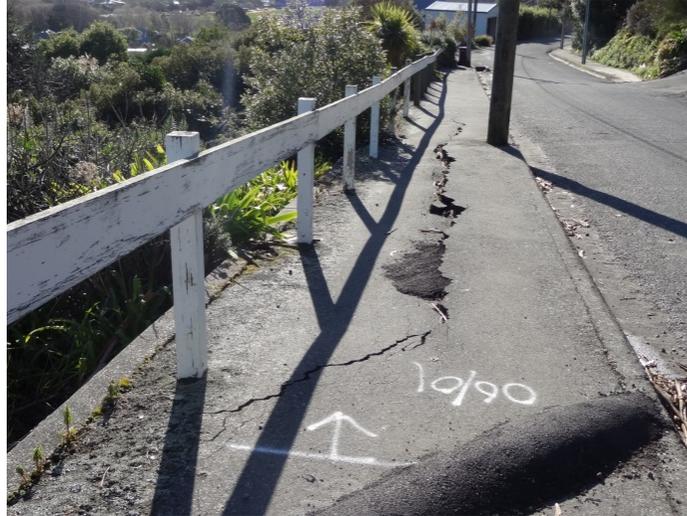
Figure 6. Footpath above a gabion wall showing cracking

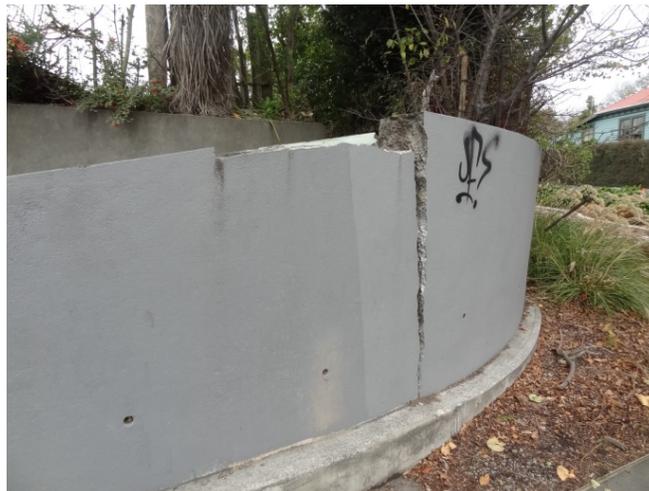
The performance of concrete walls could often be attributed to the pre-earthquake condition of the structure. For example a poorly reinforced or badly maintained wall would be more likely to be damaged. Cracking was usually at points of weakness and often resulted in excess rotation, rather than collapse as shown in Figure 7. One wall which performed well had been constructed as part of a hospital complex c.1900. Despite the age of the wall it showed no damage, except to a parapet which cracked as shown in Figure 8.

Figure 7. A typically damaged concrete retaining wall

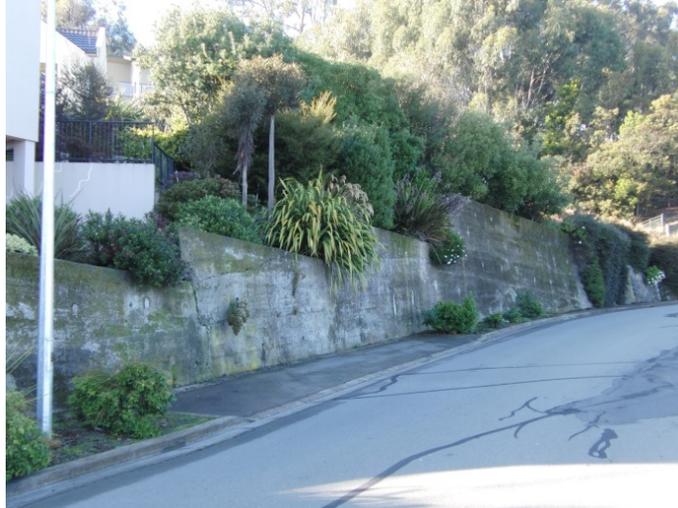
Figure 8. A concrete retaining wall c.1900 showing little damage

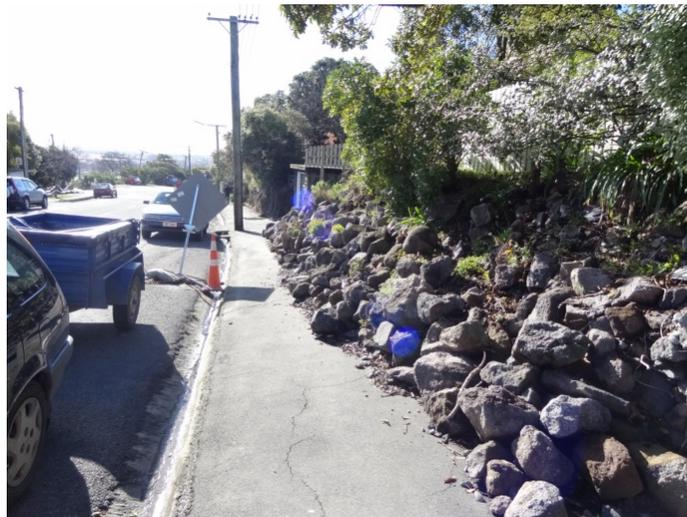
There are many stone walls in Christchurch. Typically these were at least 100 years old and were not engineered. It was not uncommon for these walls to have suffered complete collapse as shown in Figure 9. In fact many of the stone walls act as a facing to protect the loess slope behind. So it was not uncommon that when the wall collapsed that the loess face remained stable. This can be seen at the top of the wall shown in Figure 10. While these walls were typically in the region of 100 years old, those which had been rebuilt more recently did perform better. This may be due to younger mortar having greater flexibility.

Figure 9. A completely collapsed stone wall

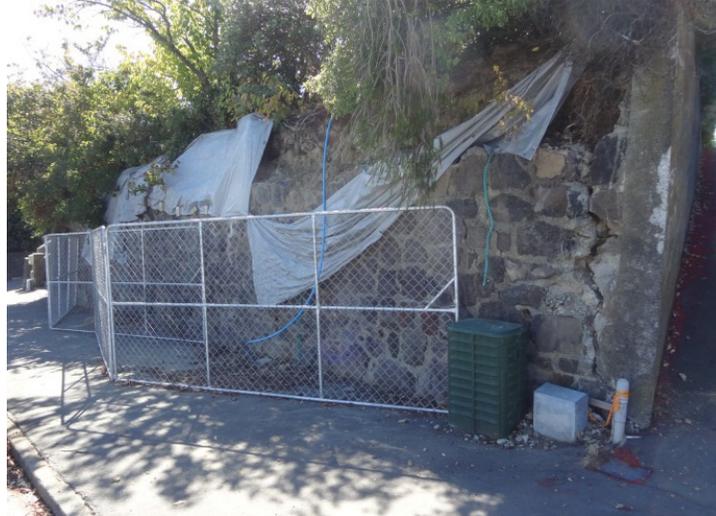
Figure 10. A partially collapsed stone wall showing typical damage

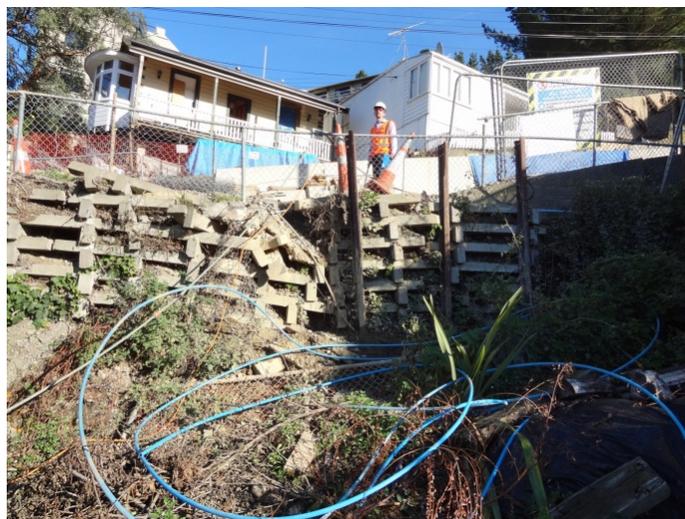
Figure 11. Damaged crib wall due for refurbishment as a soil nail wall

The analysis of a soil nail wall considers the nails to form a solid mass of soil which can resist soil and earthquake loading. In this case the existing crib wall is also considered to be part of this mass. An example of this can be seen in Figures 11 and 12.

In order to install soil nails through this crib wall the nails had to be drilled through a PVC casing through the crib units. Ideally the angle of the nails would match that of the crib units so as they do not need to be drilled through the rear stretchers, but this location had shallow buried services behind the wall which meant that the anchors had to be steeper and therefore extra drilling was necessary. A shotcrete facing was applied as the final face and this would hold in place the existing crib fill in the event of a future earthquake and maintain the mass of the structure.

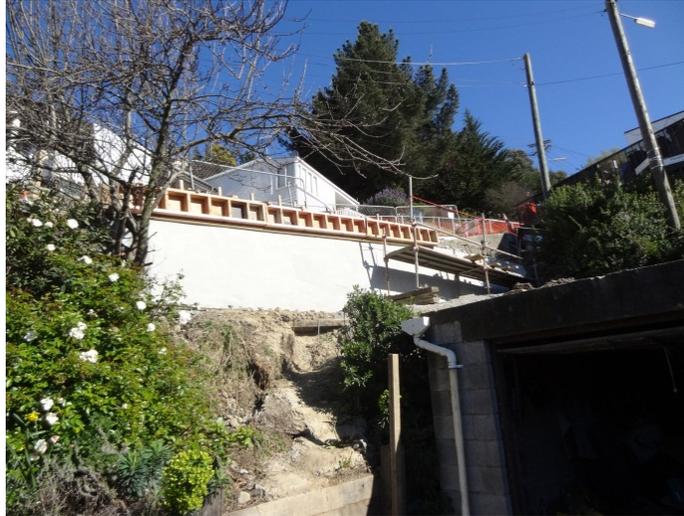
Figure 12. A soil nail wall refurbishment with shotcrete facing

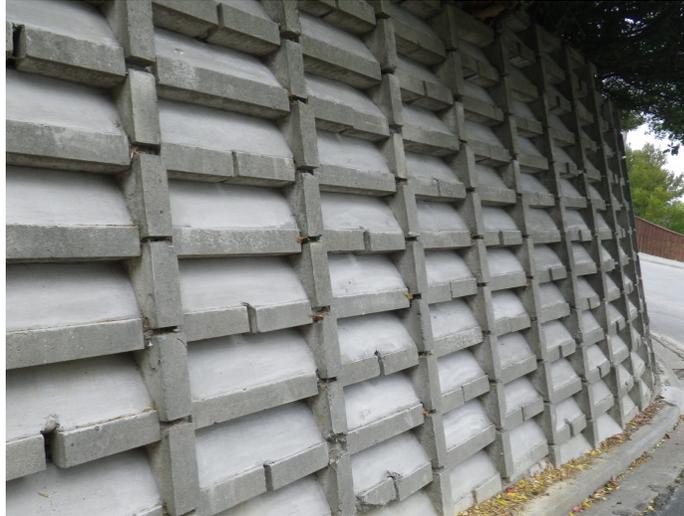
Figure 13. A crib wall with minor repairs to prevent future loss of fill

Some walls had minor damage to individual crib units and were at risk of loss of fill. These could be repaired by adding something to the front of the wall to block the front of the crib units. Options developed for this included cast in place concrete or geotextile strips. An example using concrete is shown in Figure 13. This would ensure the stability of the wall. Where the front of the wall became a solid face, drainage weep holes were also included in the design.

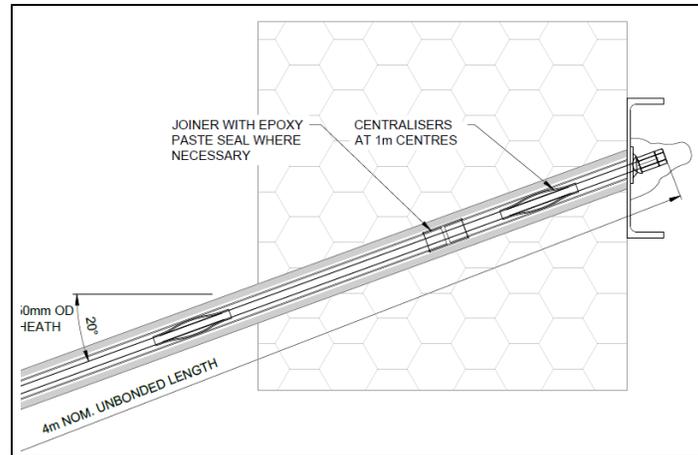
Figure 14. Sketch showing arrangement of anchors through gabion baskets

The anchored solution, shown in Figure 14, is designed to prevent further deformation under future seismic loading. In this case a PFC waling will span between anchors on the face of the wall. Drilling anchors through the gabion baskets was achievable, but there were some particular lessons learnt:

- Drilling of the anchors was possible and while the basket mesh at the rear of the basket was awkward to penetrate, it could be done.
- During grouting there is no grout recovery and therefore there is less certainty regarding how complete the grout is. Therefore all anchors were load tested.
- The testing regime needs careful consideration because measuring deflection was challenging because the baskets did not provide the required reaction for the jacking during testing.
- The gabion baskets were damaged by the plate used in testing. Therefore using a textile layer or other protection under the plate is recommended.
