## Geotechnical Performance and Analysis of ANZAC Bridge Following the 2010/2011 Canterbury Earthquakes

M.F.S. Lazzaro<sup>1</sup>, I.J. Froggatt<sup>2</sup>, P.T. Aynsley<sup>3</sup>

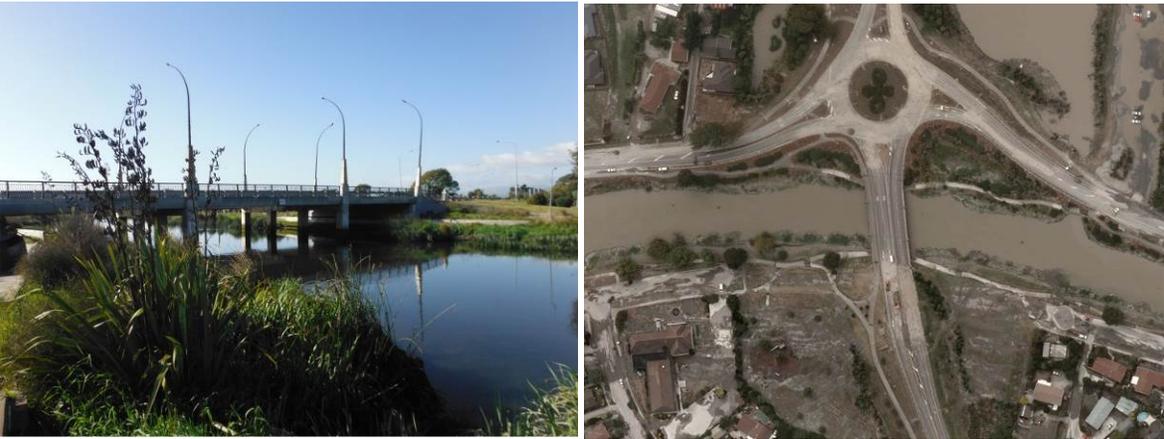
Figure 2 Anzac Bridge from bank (left) and aerial following Feb 2011 Earthquake (right)

The CGD is available to professional engineering companies involved with the Canterbury recovery. The database includes map layers which show the extent of observed liquefaction ejecta, lateral spreading damage and ground cracking. The mapping was completed shortly after each event and indicates widespread liquefaction and lateral spread damage (including ground cracking) in the surrounding area following the February 2011 event. Widespread surface manifestations of liquefaction can be seen in the aerial provided in Figure 2.

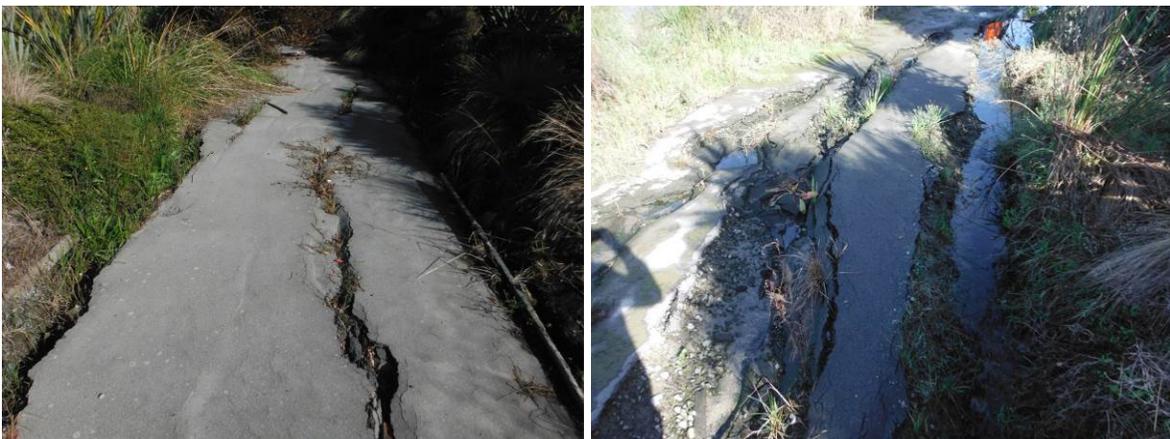
It is acknowledged that some of the evidence of lateral spread and liquefaction has been lost over the three years since the February 2011 event particularly in grassed and vegetated areas; however evidence of lateral spread was observed near the north abutment. The footpath either side of the north abutment includes sections damaged by long, open cracks parallel to the Avon River. Figure 3 shows some of the cracking inspected.

Figure 3 Footpath beside north abutment

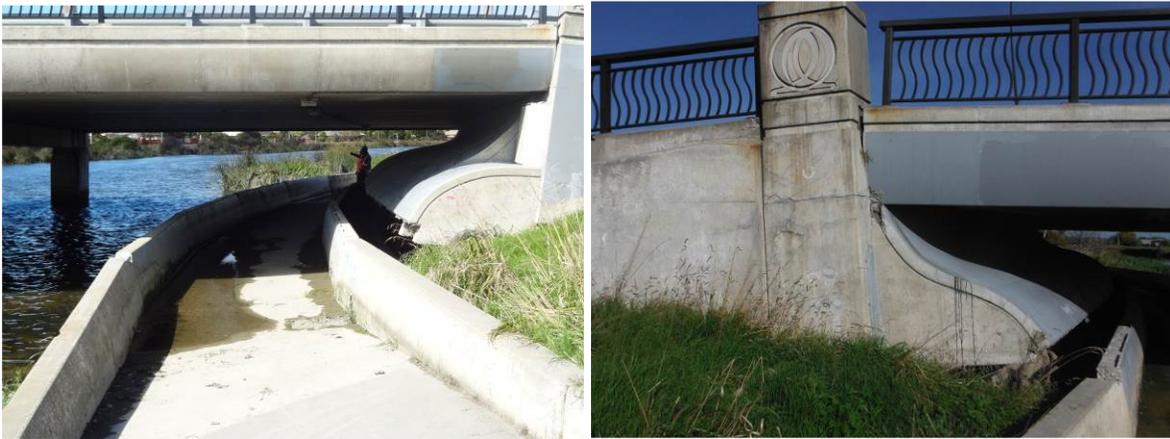
- The abutments and the steel piles (310UC137) supporting them have rotated towards the river by 4° to 6° as evident from measurements of the abutment, the abutment piles and the light poles connected above the abutments. The abutment ‘hood’ has significantly tilted up forming a large gap with the pedestrian underpass wall. Figure 4 shows the rotation of the south abutment from the west and east side of the bridge;
- The pedestrian underpasses beneath the bridge has displaced horizontally towards the river by between 300mm and 750mm.

Figure 4 Rotation of south abutment from west (left) and east (right)

The steel piles at each abutment are sufficiently damaged (yielded) and require replacement. As part of the remediation works two new piles will be provided under each abutment beam and have been designed to withstand the lateral loads imposed by the spreading crust. The piles will penetrate the liquefiable Unit 2 sands and find partial fixity within the dense sands of Unit 3.

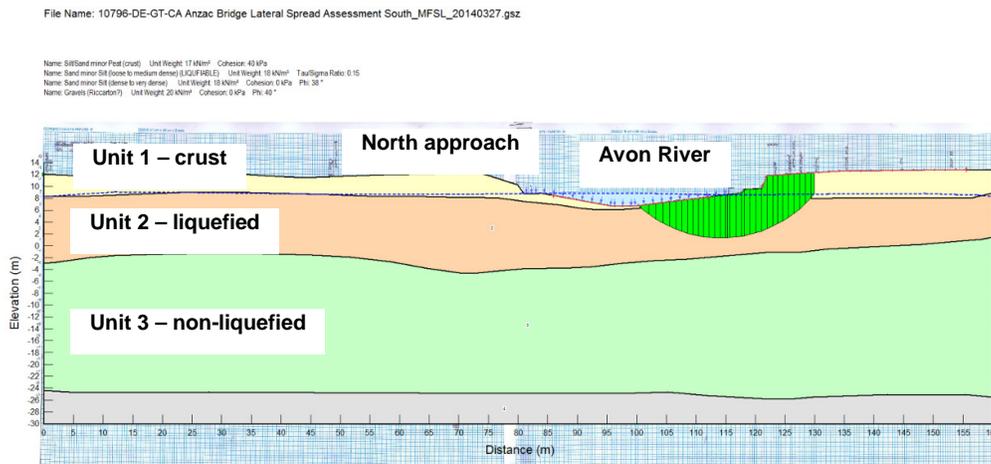
Limit equilibrium (Slope/W) was used to estimate the yield acceleration using a  $\tau/\sigma$  of 0.15 (based on available charts and cone tip resistance) for the Unit 2 soils. The acceleration was increased until a FoS of 1 was achieved. A FoS of 1 indicates the minimum acceleration required to initiate downslope movement. A yield acceleration of 0.012g and 0.009g was required to obtain FoS=1 for the north and south abutment, respectively. Output from Slope/W is provided below as Figure 5.

Figure 5 Slope/W output for south abutment lateral spread assessment
