Reconnaissance Highlights of the 2014 Sequence of Earthquakes in Cephalonia, Greece

ABSTRACT

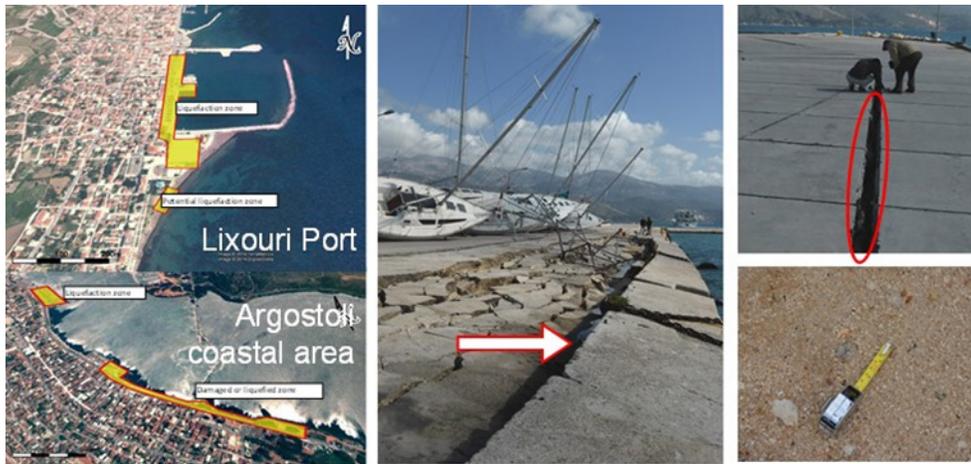
Additional observations include liquefaction of Holocene coarse-grained sediments, rock falls, and landslides. Widespread, repetitive liquefaction and lateral spreading were observed primarily at the main ports of Lixouri and Argostoli, within 10 km from the epicenters (Figs. 1, 3). Quay walls displaced laterally by as much as 1.5 m in Lixouri and less in Argostoli. Liquefaction manifested at ground surface on soft sedimentary sites as large displacements of pavements, and extensive coarse grained (> #4 sieve) gravel particles were observed in ejecta throughout both ports. The two other ports, Sami and Poros, were farther from the epicenters and experienced minimal damage.

Figure 3. Liquefaction zones at two main ports of Lixouri and Argostoli (left). Lateral spread at Lixouri quay wall (middle); opening of joint at pier and evidence of gravel in ejecta (right).

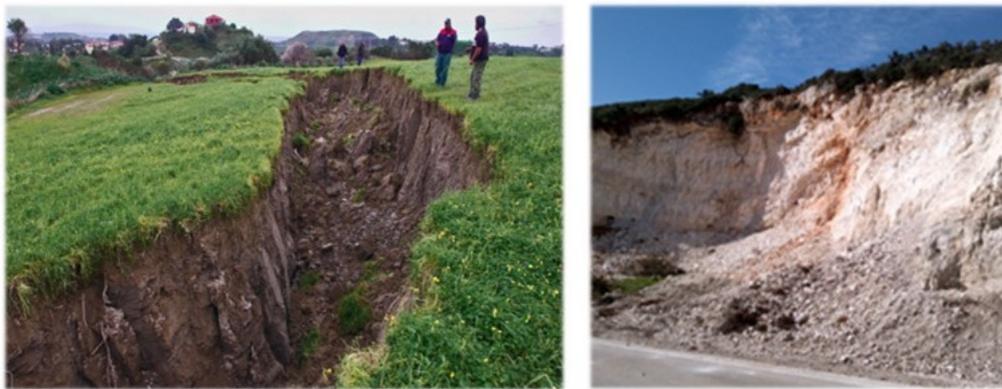
Landslides and rock falls were observed at the west: More than 40 rock shallow slides and a deep-seated bedrock slump in natural slopes were recorded (Fig. 4), as well as numerous dry-stack masonry retaining walls. Two major landslides involved settlements of man-made embankments. Soil-structure interaction effects of differential deformations between pavements and structures were observed (Fig. 5). Still, the relatively mild structural damage in Lixouri's reclaimed area could be partially attributed to a layer of unsaturated fill on top of liquefied layers that acted as a "protective cap."

Figure 4. Landslide and rock slope failure examples.

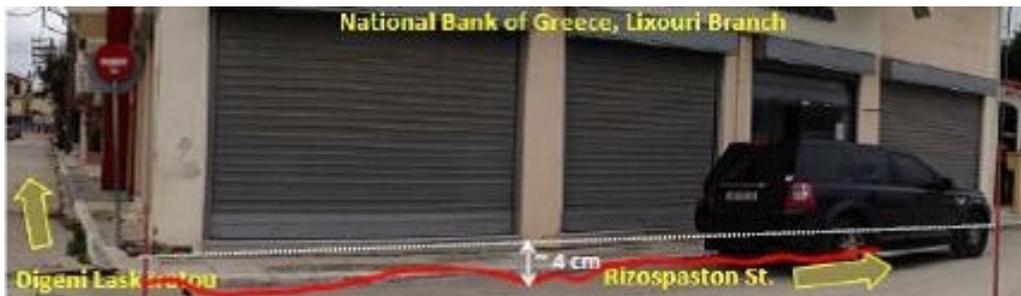
Figure 5. Settlements between the base of the National Bank Lixouri branch and sidewalk.

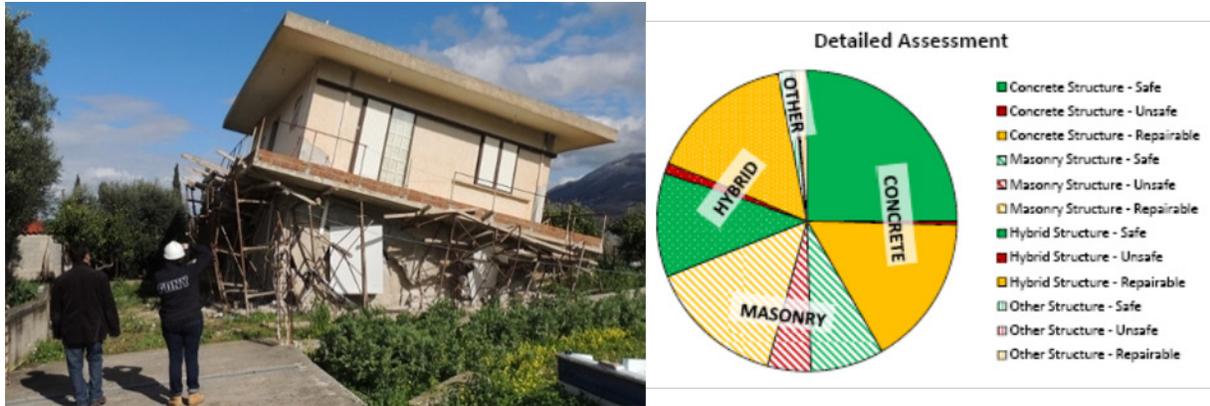
- RC buildings of older seismic codes with large stirrup spacing (> 300 mm), lack of confinement at beam-column joints, and poor detailing.
- RC buildings with soft stories at the ground level.
- Mixed structural systems which usually included a masonry ground floor and a RC upper floor, built in phases over the course of several years (Fig. 6).
- Old masonry buildings and churches which survived the 1953 events and had been repaired.

Figure 6. Mixed construction collapse (left); detailed assessment of 2,770 buildings (right).

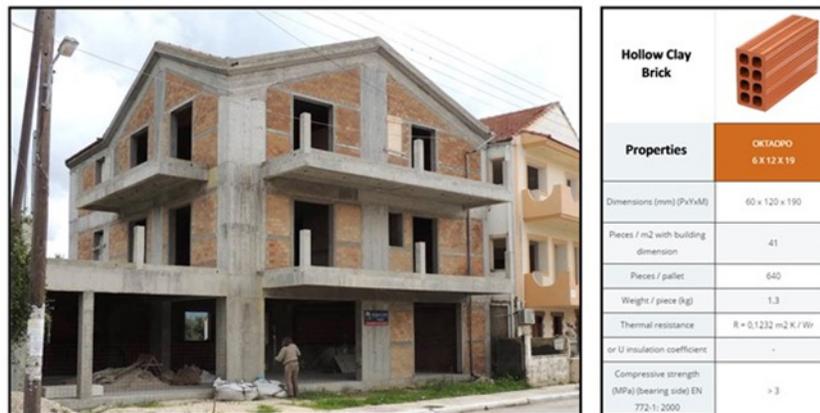
The predominant structural type (Fig. 7) is a mix of reinforced concrete (RC), masonry infill, and wood roofs, 1–4 stories high. The infill has concrete beams around openings dowelled to the RC structure. This practice is unusual, but was resilient given the fact that in the 2nd event SAs peaked at 3 g in Chavriata and 1.5 g in Lixouri, exceeding max elastic code values by 1.25 to 2.5 (Fig. 2). Depending on the design Response Modification Factor (R) factor, the recorded SAs could have generated actual seismic loads that were higher than design by an astounding factor of 2.5–8.5 (for R of 2–3.5). Reconnaissance data have already initiated resiliency studies (Nikolaou et al., 2015).

Figure 7. Confined masonry construction (left); properties of infill clay bricks (right).

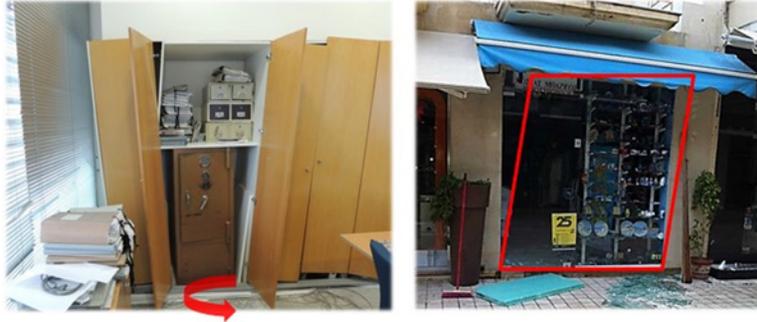
Nonstructural component deficiencies included inadequate bracing/anchorage to structure, roof tile collapse, lack of fence foundations or design for interstory drift, lack of seismic stoppers for rolling storage racks, absence of flexible joints in piping, lack of floor/wall connections of heavy furniture, bookcases and bank vaults, and unsecured objects (Fig. 8). This affected the everyday life and economy, but serious injuries or loss of life were avoided.

Figure 8. Nonstructural damage: Sliding and rotation of bank vault (left); glazing failure (right).

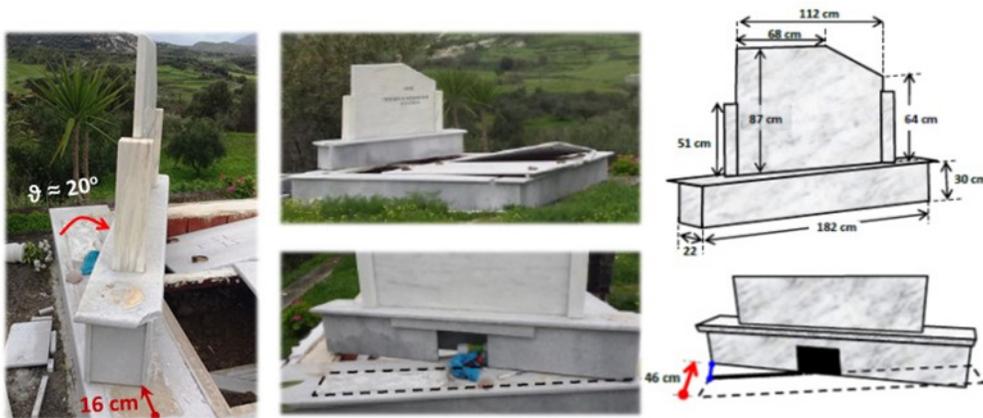
In stark contrast with the overall excellent building performance, extensive damage was observed in the 18 cemeteries of the Paliki peninsula and 9 others on the island. The main cause of tomb damage was toppling on the grave marble slab. Other failure patterns included slippage, vertical separation, and/or rotation of blocks and tombstones without toppling (Fig. 9). The toppling rate was surprisingly low in the fault vicinity and concentrated in the peninsula at a rate of ~67% of objects toppling, and dropped to ~20% on the main island and zero at the east. Controlling factors were block geometry and near field directivity effects. Since cemeteries are built on a hill, topographic amplification likely contributed. Information in the GEER/EERI/ATC report can contribute to research on the highly nonlinear seismic block behavior.

Figure 9. Photos and sketches with dimensions and displacement of a rotated headstone.

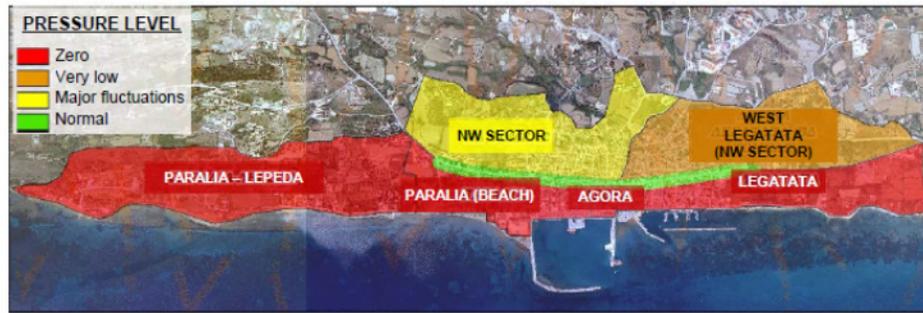
The potable and wastewater networks suffered notable damage mainly due to the 2nd event. The Athens Water Supply & Sewerage Co. EYDAP responded rapidly with field and repair teams and provided their report for incorporation in the GEER/EERI/ATC findings. Since electronic mapping of the network was not available, EYDAP develop a GIS map of 36,191 m of water pipes based on available maps and Digital elevation models (DEMs) from satellite data. The assessment of the first day (2/6/14) is shown on Fig. 10: **Green** – normal operation; **Yellow** – significant fluctuations in pressures; **Orange** – very low pressure; and **Red** – zero pressure. The properties of the water pipe network are shown on Table 1. Damage was found to be concentrated to the Asbestos Cement Pipe network.

Figure 10. Rapid network assessment at the end of the first day, 2/6/14 (EYDAP, 2014).
