## Over-turning of a building with pile foundation - combined effect of liquefaction and tsunami

T. Tobita<sup>1</sup>, and S. Iai<sup>2</sup>

### ABSTRACT

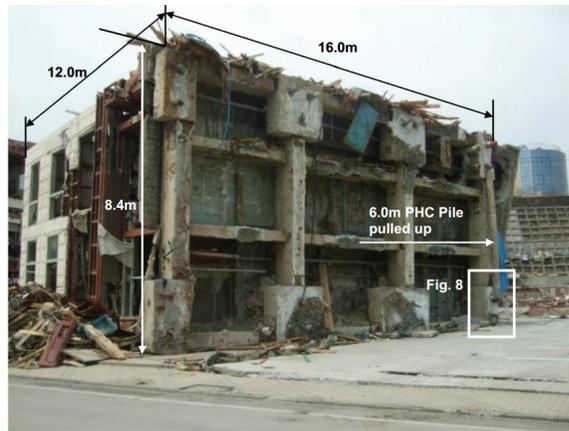
In the present study, the mechanism of overturning of pile supported buildings was investigated through centrifuge experiments and numerical analysis. In Onagawa town, one steel-framed building was overturned with one of its piles still attached to the footing. (Fig. 2) (Konagai et al. 2011). The cause of damage was speculated as combined effects of the tsunami and softening of the ground due to liquefaction, although the site was washed by the tsunami and very little evidence of liquefaction remained. The failure mechanism of pile supported buildings may be thought of as (1) loss of bearing capacity, (2) loss of lateral resistance and skin friction of piles due to liquefaction, then (3) deformation of the ground due to the hydrostatic and hydrodynamic force of the tsunami, and (4) buoyant and thrust forces acting on a side of the building.

Figure 2. Overturned steel-frame building (Eshima Kyosai Kaikan) (Konagai et al. 2011).

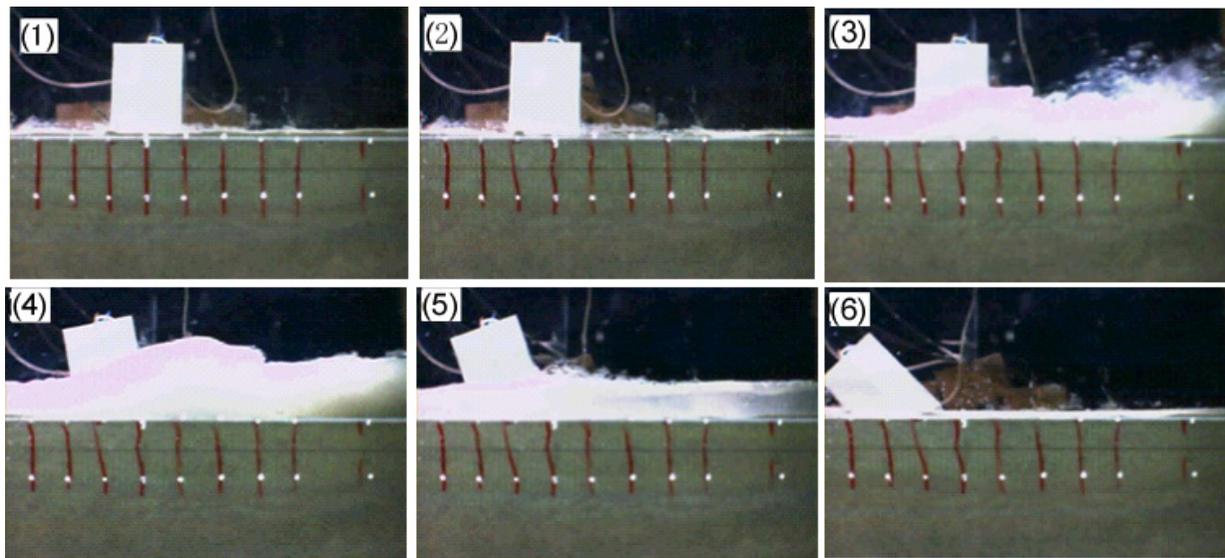
Figure 4. Sequence of overturning of the model building (Case1-1).

As an example, the sequence of overturning of the model building for Case 1-1 is shown in Fig. 4. In Case 1-1, tsunami arrival was just after shaking, when the excess pore water pressure was still high, i.e. the ground was under liquefaction. As shown in Fig. 4(1) to 4(3), the building

sustained shaking. However, in Fig. 4(4), when the maximum height of the tsunami was observed, the building started to tilt and remained permanently inclined [Fig. 4(6)].

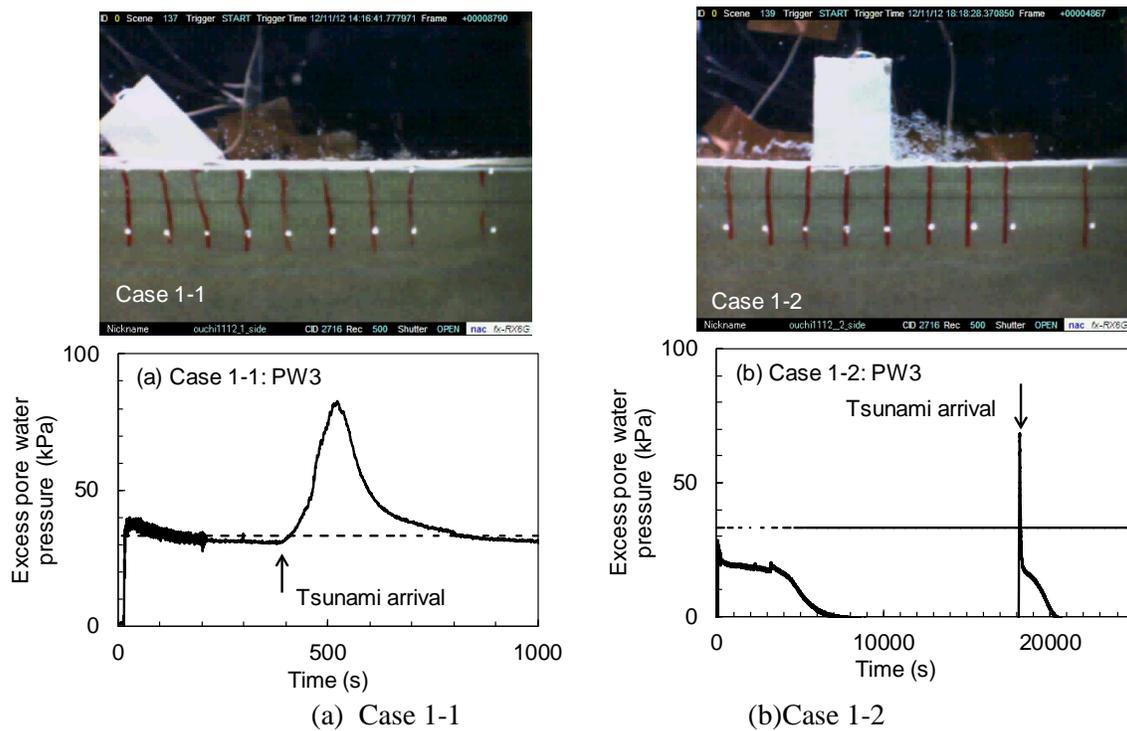
In the centrifuge tests, the timing of tsunami arrival played a dominant role in the failure of the model building. As shown in Figure 5(a) for Case 1-1 and Fig. 5(b) for Case 1-2, when the tsunami hit the building during liquefaction, as shown in the time history of excess pore water pressure buildup (measured at PW3 in Fig. 3) in the bottom figure of Fig. 5(a), it tilted (Case 1-1), while it did not tilt if the tsunami arrived after complete dissipation of the excess pore water pressure in the ground. Considering that the strength of the ground during liquefaction is extremely small, the result seems to be quite reasonable and agrees with the speculations above.

Figure 5. Effect of liquefaction on the overturning of the model building due to tsunami: (a) Case 1-1: with liquefaction and (b) Case 1-2: without liquefaction.

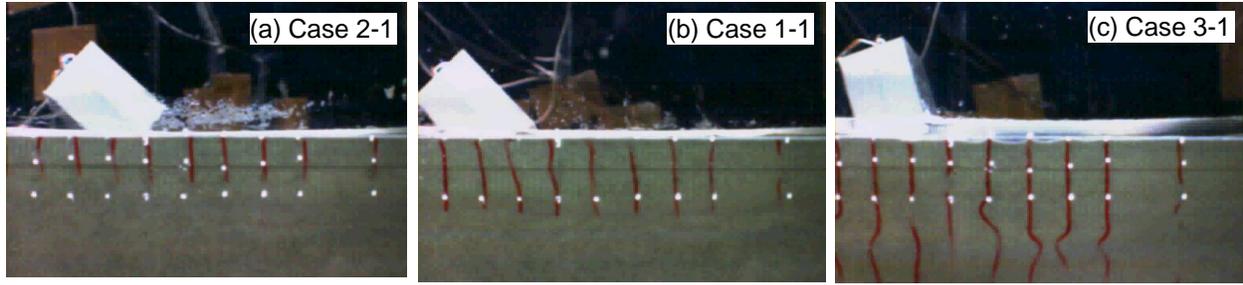
Then, the effect of the thickness of the liquefiable layer was investigated to confirm whether the loss of lateral resistance of piled foundations, which is dependent on pile length, had significant impact on the stability of a model building. To take into account the pile break at the boundary of the loose and dense sand layers, the pile length was kept at the same length as the thickness of the loose liquefiable layer. As shown in Fig. 6, the shorter is the pile length, the larger is the inclination of the building. Thus, it confirmed that a loss of lateral resistance of piled foundations caused overturning of a model building.

Figure 6. Overturning of a model building: (a) Case 2-1: thickness of the liquefiable layer (=pile length) 4.6 m, (b) Case 1-1: 8.6 m (c) Case 3-1: 16.6 m.

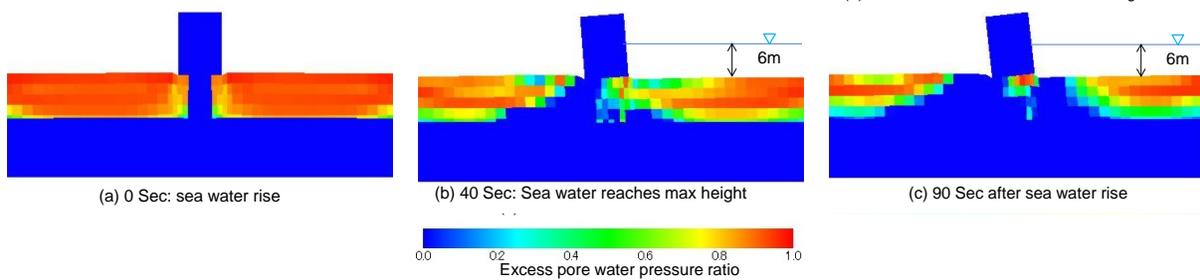
Contours showing excess pore water pressure ratios in the ground before application of the tsunami [Fig. 9(a)] indicate that the surrounding ground was totally liquefied. As time passed and thrust force due to the tsunami increased [Fig. 9(b)], the excess pore water pressure close to the building decreased, especially on the inland side, because of large shear strains associated with deformation of the building. The excess pore water pressure ratio under the building on the sea side markedly increased [Fig. 9(c)] because of the uplift of the foundation associated with rotation of the building. This implies that the ground near the surface under the building was kept liquefied and, therefore, became vulnerable to scouring.

Figure 9. Deformation and distribution of the excess pore water pressure ratio.
