Ground Deformations in the Very Near Fault Region during the M6.0 South Napa Earthquake

ABSTRACT

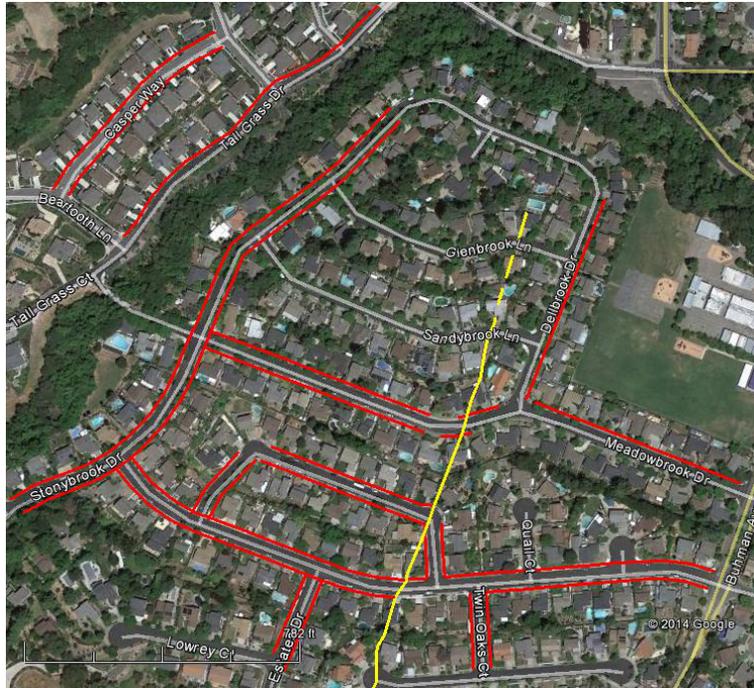
Figure 1: Observation and measurement sections of ground strain (red lines) and approximate observed fault trace (yellow line); produced in Google Earth; [Napa, CA; N 38.3040 W 122.3443; 8/26/14 - 8/28/14]; Bray et al. (2015).

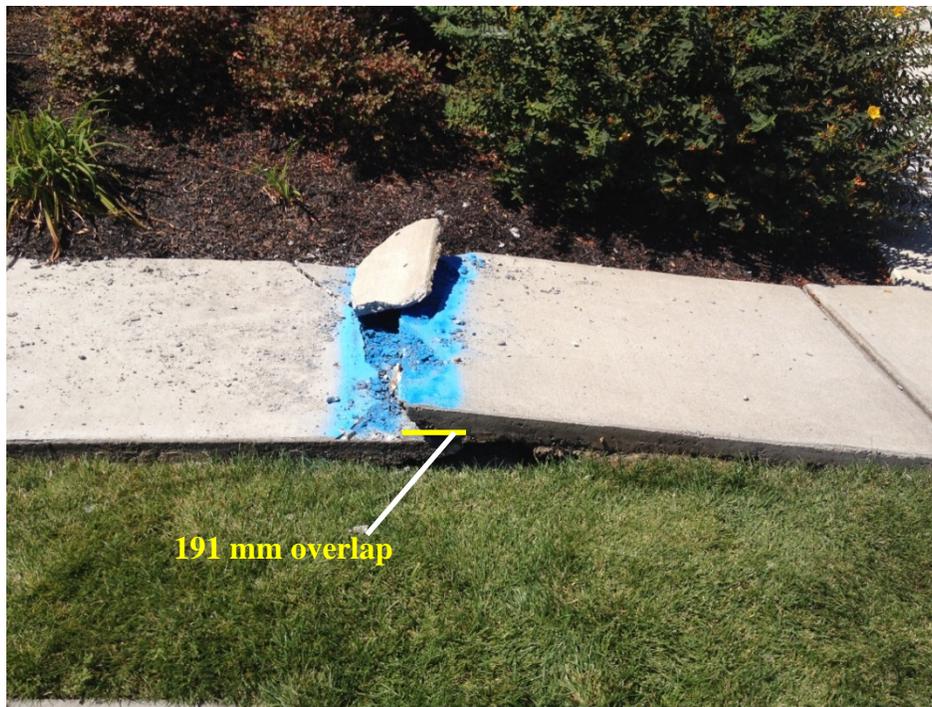
In some locations, compression in the sidewalk pavement manifested as an overlap instead of a buckled section. In such cases the overlap was measured and recorded as the compression in the zone. The measurement for an overlapping compression zone is shown in Figure 4. In cases where both gaps and overlaps were observed, the gaps were subtracted from the overlap measurement and this value was recorded as the compression in the zone. The measurement for an overlapping compression zone with a gap is shown in Figure 5.

Figure 4: Measuring an overlapped compression zone in sidewalk pavement [N 38.3065 W 122.3454; 8/28/2014 14:00]; Bray et al. (2015).

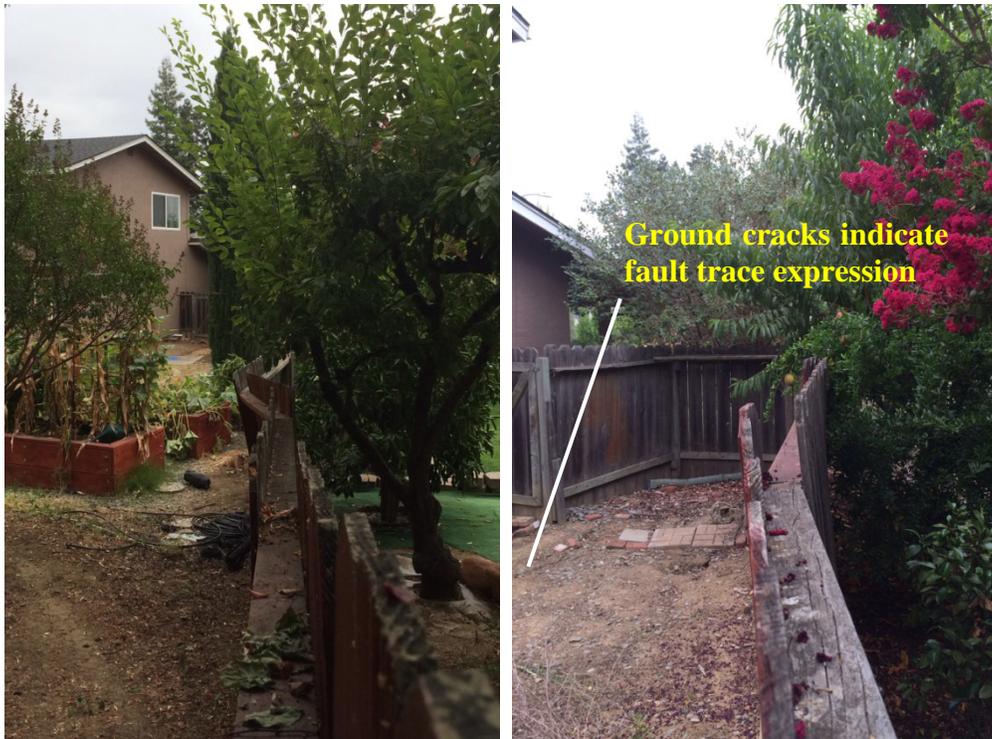
Permanent deformation was also observed on a section of a fence running parallel to and adjacent to the fault trace (Figure 8). To compute the strain, the horizontal boards at the top of the fence were measured in segments to obtain an estimate of the original length of the fence. Then, the ground along the base of the fence was measured to obtain an estimate of the new length of the fence. The average strain in the fence was the same order of magnitude as the average strain in the sidewalk pavement for roads crossing the fault trace.

Figure 8: Buckled section of fence for strain measurements [N 38.3015 W 122.3442; 8/25/2014 09:57]; Bray et al. (2015).
