6th International Conference on Earthquake Geotechnical Engineering
1-4 November 2015
Christchurch, New Zealand

Ground Improvement by Impact Compaction for Building Founded on Liquefiable Soils

N. Barounis¹ and G. Saul²

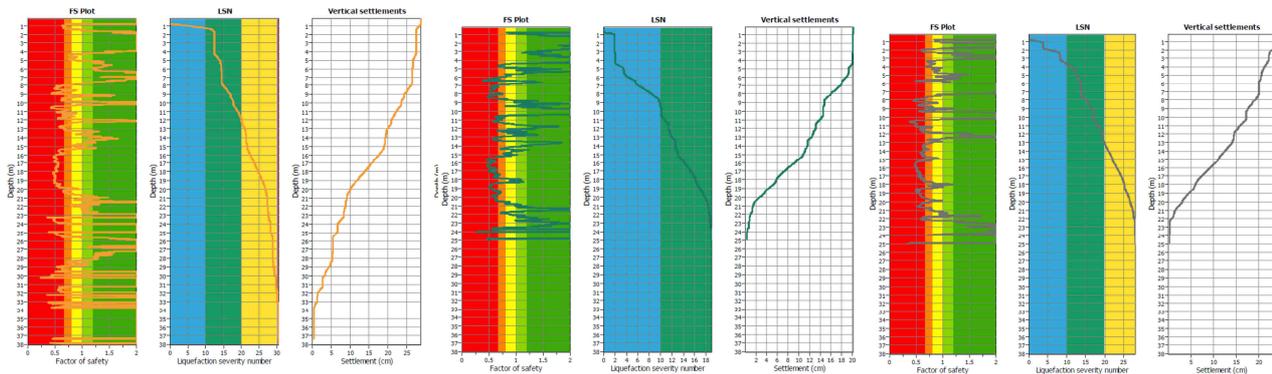
Figure 2: Liquefaction analysis results for ULS event based on Boulanger and Idriss (2008) method (CPT 1 to CPT 3 is from left to right).

The liquefaction analysis results obtained from the CPTu using CLiq software are presented in Figure 2 and Table 3. The Boulanger and Idriss (2008) method was used for both SLS and ULS and Robertson's method (2009) for ULS.

One of the main problems detected from the liquefaction analysis (refer Figure 2) is shallow potentially liquefiable layers of loose sand. These ground conditions create serious problems for placing directly on the ground any type of conventional shallow foundation. Both methods used produce significant liquefaction subsidence, with Robertson’s method consistently estimating thicker non-liquefiable zones than Idriss and Boulanger’s method (see Figure 3). These results are comparable with the observed total settlement of up to 270mm, with Boulanger and Idriss method to provide an estimation closer to the observed settlement. In any case both methods come to the same conclusion that shallow foundation is not a viable solution against a ULS event as both methods estimate subsidence in excess of the total allowable settlement of 50mm. However, the analysis indicates liquefaction induced subsidence for the serviceability event of less than 25mm. This amount of settlement is considered as tolerable for shallow foundations.

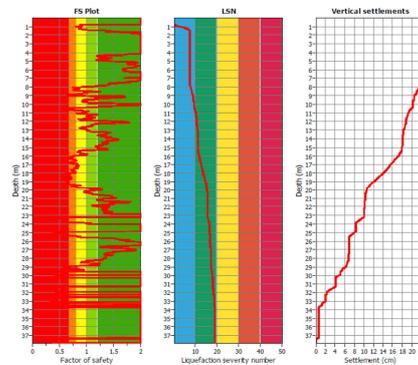
Figure 3: Robertson’s method indicates a non-liquefiable crust between 1.5m and 8m depth

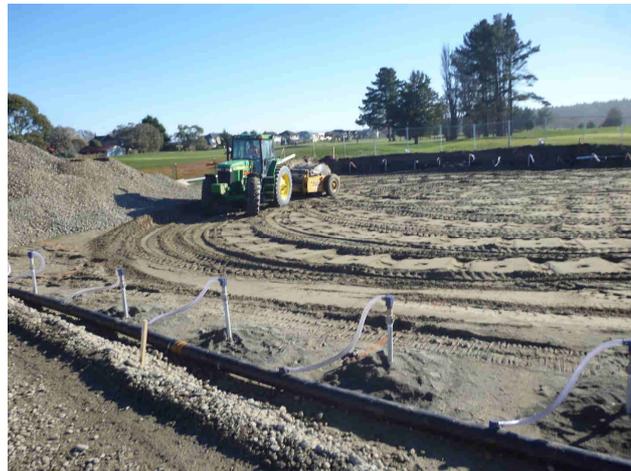
Figure 4: Impact compactor in action.

The impact compaction took place by using a tractor towed 13ton impact compactor of square cross section with 1m height. The input energy rating for this impact compactor was 31kJ per blow. The complete technical data of the compactor are presented in Table 4.

The impact compactor densifies soils by dropping a weight from a height at a regular rate. The compaction was carried out for three consecutive days with 500 to 1000 passes. Grid survey of levels with accuracy of $\pm 5\text{mm}$ indicates that after the impact compaction was carried out, the site was lowered by 200mm. The engineered fill was reinforced with four layers of biaxial geogrid at 400mm vertical spacing. A bi-axial E-Grid 30/30 geogrid was used with AP65 material. The achieved relative compaction as measured by NDM testing was found to be greater than 95% in all measurements, at all recommended points inspected. The field NDM testing was undertaken according NZS 4407:1991 Test 4.2.2 and the determination of the dry density/water content relationship according NZS 4402 Test 4.1.2. For the placement of the fill the approach recommended by the Specification for Highway Works (Barnes, 1995) was implemented.

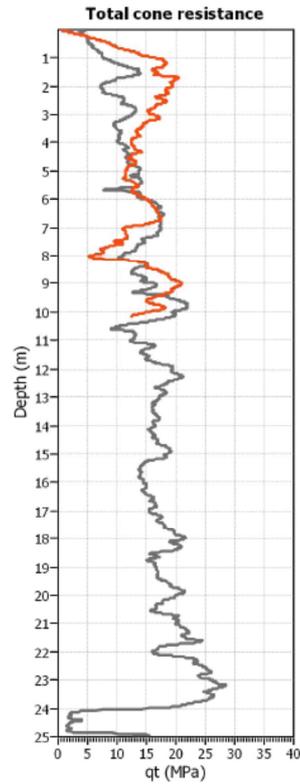
Figure 5: Total cone resistance increased (orange colour) after the impact compaction treatment to the depth of 2m.

In order to measure the achieved degree of improvement, three CPTu were carried at post treatment of the site at the same initial CPTu locations. The average results are summarized in Table 5 and Figure 5. In general, the impact compaction is not very effective when saturated loose silty material is present near the compactor. For this reason the engineered fill was adopted in the design for mitigating the risk from the silty material to inhibit the ground improvement from impact compaction.

The impact compaction has increased q_c by an average of 30% to about 2m depth. The influence of the impact compaction below this depth is diminishing with depth as was expected. In general the liquefaction induced subsidence at SLS remained at the same levels as before the treatment. The main difference from the treatment is observed at ULS where the subsidence was reduced between 5mm and 35mm, depending on the analysed CPTu for the top 10m. It is believed that the silty material present in the top 0.5m of the treated soil was dilating during impact compaction, as this dilation was monitored by surveying. This means that the level of improvement may have been higher if the silt content was lower. The building was constructed on time and within the budget.
