Liquefaction Induced Flooding in Christchurch, New Zealand

C. A. Davis¹, S. Giovinazzi², D.E. Hart³

ABSTRACT

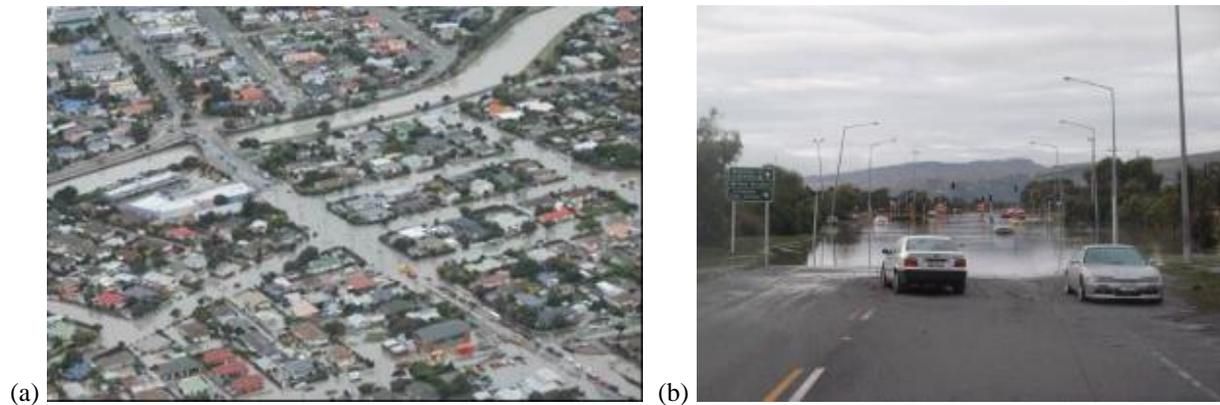
Figure 1 shows flooding after the February 22, 2011 Christchurch earthquake resulting from large volumes of liquefaction-induced water bubbling out from the ground in portions of the city, which was compounded by water flowing from broken pipes and groundwater wells. The liquefaction process is well understood and can be found in numerous references (e.g., Idriss and Boulanger, 2008). This section does not provide new information on the liquefaction process, but instead summarizes the process as it relates to the flooding observed in the Canterbury region, using surficial flooding and erosion as an analogy, and provides a technical context for the impacts on community and lifeline systems.

Figure 1. Typical liquefaction induced flooding of Christchurch suburbia from Feb. 22, 2011. (a) Aerial view of estuary-proximal suburb of Bexley (Crown Copyright 2011, NZ Defence Force – Some Rights Reserved). (b) Flooding of Anzac Dr. (courtesy T. O’Rourke).

as shown in Figure 1b. Settlements from solidification and soil ejection occurred as the liquefaction-induced floodwaters were ejected to the ground surface; that is, the ground was settling as water was ponding on the lowered ground surface. In a sense, a bowl shape was formed giving an area to hold the ejected water. As shown in Figure 1, many streets were inundated with water several tens of centimeters deep. Vast volumes of surface deposits were removed after each event, combining with the accumulation of the three primary settlement mechanisms to enhance the liquefaction-induced flooding potential for each subsequent earthquake event. Cumulative settlement reached 0.3 to 1 m in different areas (GEER, 2014).

Figure 1b shows a photograph of flooding on Anzac Dr. following the Feb. 22, 2011 earthquake

in the Bexley suburb. The water depth at time the photograph was taken is estimated as 200 to 300 mm based on curbs completely covered with water and the car bumper in the background above water. Settlement in Bexley was about 300 mm for this earthquake. The reported settlement and observed flood depths are consistent with liquefaction ejecta causing flooding, as seen in Figs. 2 and 3. Further investigations are warranted to confirm these initial observations.

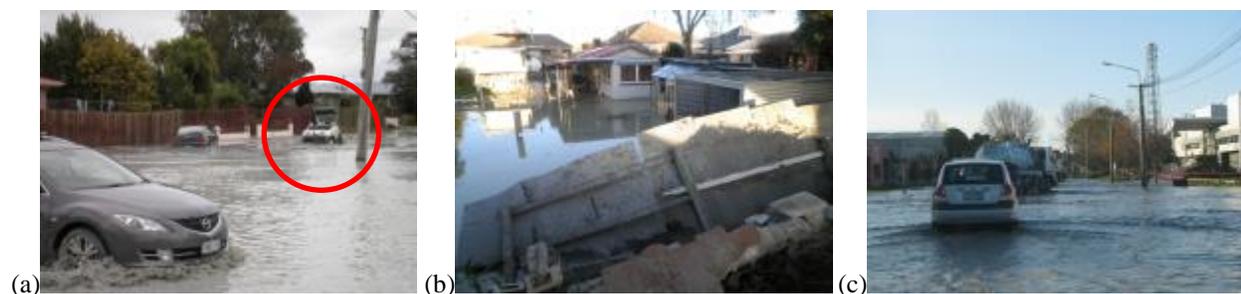
Liquefaction-induced flooding occurred in Christchurch city and nearby towns in all the previously identified significant earthquake events within the sequence. Figure 4 presents some examples of liquefaction-induced flooding in different locations and earthquakes. Not all liquefied areas sustained flooding following the earthquakes. Many areas experienced liquefaction-induced water and soil ejecta at the ground surface, without experiencing flooding, due to insufficient water spouting from the ground, little or no damage to pipelines, and/or sloped ground allowing ejected water to drain rapidly. Some areas experienced liquefaction induced flooding from several of the earthquakes, while other areas only experienced flooding from a single event. Those areas which experienced liquefaction-induced flooding were generally low-lying and relatively flat, underlain by thick soil deposits having a relatively high liquefaction potential and, crucially, featured shallow groundwater. Communities suffering significant liquefaction-induced flooding in at least one earthquake include: Aranui, Avondale, Avonside, Bexley, Bromley, Burwood, Central City, Ferrymead, Halswell, New Brighton, Parklands/Queenspark, Richmond, Shirley, Wianoni, and Woolston/Brookhaven. Large inhabited areas were inundated, as seen in Figure 1, in all events resulting in liquefaction-induced flooding of streets and properties, including homes and businesses. In total these areas directly impacted at least tens of thousands of people multiple times resulting in extensive infrastructure and property damages and associated economic impacts. Observations were also made in large open park spaces and rural fields, where no developments or underground piping exist. While these rural areas may have suffered little-to-no economic impact, they do provide evidence for the source of flooding coming from the liquefaction process. Further evidence comes from flooding in urban areas at elevations above river level, and in backyards contained by walls and fencing (e.g., Figure 4b; <https://www.youtube.com/watch?v=gDkLPLCC Ok>).

Figure 4. Liquefaction-induced flooding impacts. (a) Feb 22, 2011 flooded street in Aranui suburb. (b) June 13, 2011 flooded property in Aranui suburb. (c) June 13, 2011 flooding streets and property in Bromley. (Photos courtesy M. Lincoln, nzraw.co.nz)

In a few cases the sinkholes posed threats to lives, where vehicles either sank or drove into sinkholes, or sank into surficial liquefied soils having no bearing strength (e.g. see in Figure 6f the same car as circled in Fig. 4a). A few vehicles became engulfed to the extent drivers and passengers could have drown. Additionally, there is documentation of people being trapped in holes from the September 4, 2010 and June 13, 2011 earthquakes, and at least in one case a lady was noted to have to claw her way out of the liquefaction (see for example <http://www.abc.net.au/news/2011-06-15/liquefaction-traps-christchurch-resident/2759046> and <http://www.nzraw.co.nz/news/fire-engine-stuck-following-christchurch-earthquake/>). There are no documented cases of severe injuries or fatalities in Christchurch resulting from this hazard.

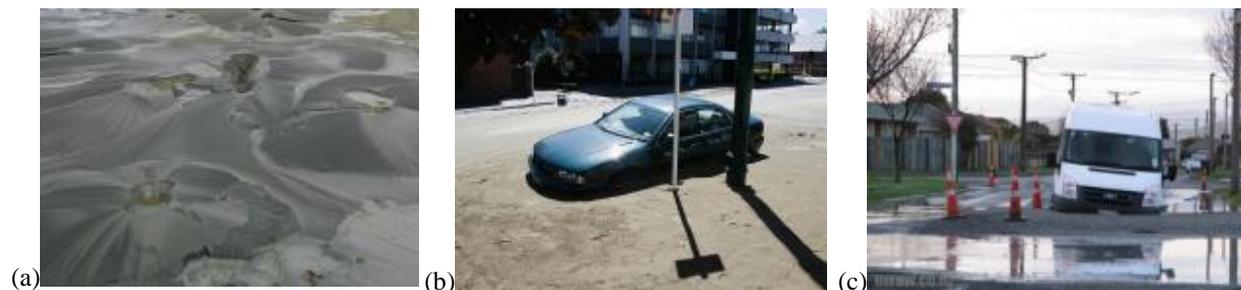
Figure 5 presents example impacts from liquefaction-induced sedimentation. Large volumes of soil were ejected onto the ground surface and flowed considerable distances which: (i) blocked drainage paths, (ii) filled catch basins, (iii) blocked streets, and (iv) trapped vehicles. Items (i) and (ii) prevented drainage of liquefaction-induced inundation while items (iii) and (iv) reduced or eliminated street functionality. The damaged pipes eroded large holes in the streets and further impacted transport capabilities through (1) soil flowing into non-pressurized sanitary sewer and storm water drainage pipes and (2) pressurized water pipes jetting and eroding holes.

Figure 5. Liquefaction-induced sedimentation impacts. (a) Feb. 22, 2011 liquefaction sediments forming cones (Curtesy T. Musson, commons.wikimedia.org). (b) Feb. 22, 2011 car partially buried in sediments (Courtesy G. Gho, commons.wikimedia.org). (c) June 13, 2011 street blocked by liquefaction sediments and trapping vehicle (Courtesy M. Lincoln, nzraw.co.nz).

The water or a soil-water slurry flow is ejected from the earth, either onto the ground surface, or into some subsurface cavity such as an underground vault, cracked or open pipe or other space. The observable ejecta are shown in Figure 3 as a water flow, often accompanied with soil when erosion takes place. Soil ejected onto the ground is commonly referred to as “sand boils”, “mud spouts”, or “sand volcanos” as a result of the ejection process looking like material boiling up or spouting from the ground, with resulting deposits forming cone-shaped mounds with central craters akin to mini-volcanos as shown in Figure 3 and Figure 5a presented in a later section.

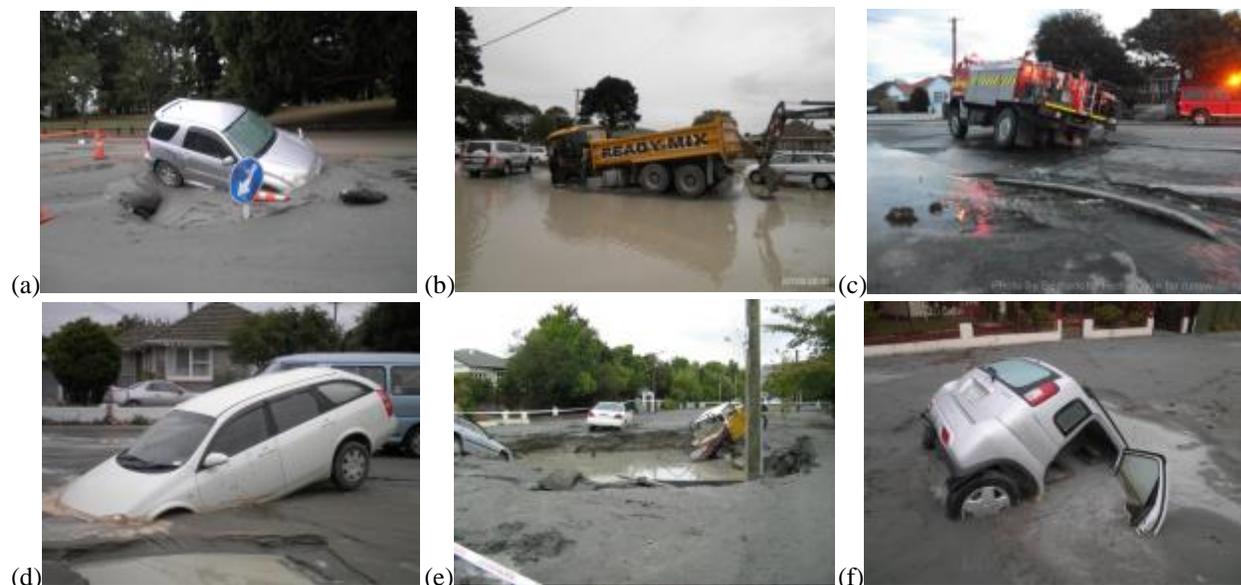
Sediment also flowed into subsurface sewer and storm water drainage pipes as depicted in Figure 6a. This flow into pipes caused several problems, including: (1) blocking sewage flow leading to sewage flooding into streets, rivers, and estuaries causing widespread contamination, (2) blocking drainpipe flow preventing drainage of liquefaction-induced flooding and enhancing the post-earthquake flood problems, and (3) sinkholes in the streets impacting transportation, mobility, safety, other nearby utilities, private property, and emergency response. Additionally, some holes were eroded from damaged pressurized water pipes.

Figure 6. Sinkholes. (a) Car being pulled into sinkhole along with liquefaction sediment flow. (b) Dump truck stuck in sinkhole obscured by water. (c) Fire engine stuck in hole Sept. 4, 2010 (Courtesy B. Richardson, nzraw.co.nz). (d) Car drove into sinkhole previously obscured by water. (e) Large sinkhole swallowing street, vehicles, and power pole (Courtesy Perduta commons.wikimedia.org). (f) Car completely engulfed within sinkhole. All photographs except (c) are from Feb. 22, 2011. All photographs except (c) and (e) courtesy M. Lincoln, nzraw.co.nz.

The subsurface erosional flow of sediments into a pipe or other subsurface void space creates different types of impacts, as shown in 6, than when the eroded sediments are ejected onto the ground surface. The sinkholes and sediment in the streets inhibited emergency response and

recovery activities ranging from emergency response vehicles shown in Figure 6c to construction equipment shown in Figure 6b to emergency water tanker trucks (e.g., http://izismile.com/2012/08/31/christchurch_liquefaction_26_pics-11.html). In many cases these sinkholes were obscured by flood waters as indicated in Figures 6b and 6d and vehicles unknowingly drove into these holes as circled in Figure 4a. As water subsided the holes retained water, and people drove into them believing they were passing over a puddle not knowing the ponding represented a deep hole (<http://news.wikinut.com/Earthquake-strike-s.-February-the-22nd-2011/19occxnq/>). In other cases the sinkholes developed directly below vehicles and sucked them into the formation. Figure 6e exemplifies how some sinkholes were very large and dangerous, opening entire streets, affecting not only transportation corridors and vehicle safety, but also other lifelines in the street and private properties.
