State Highway 74 Seismic Rockfall - Predicting Its Impact, Assessing Its Risks and Managing Its Effects

M. R. Easton¹, P. R. Eastwood²

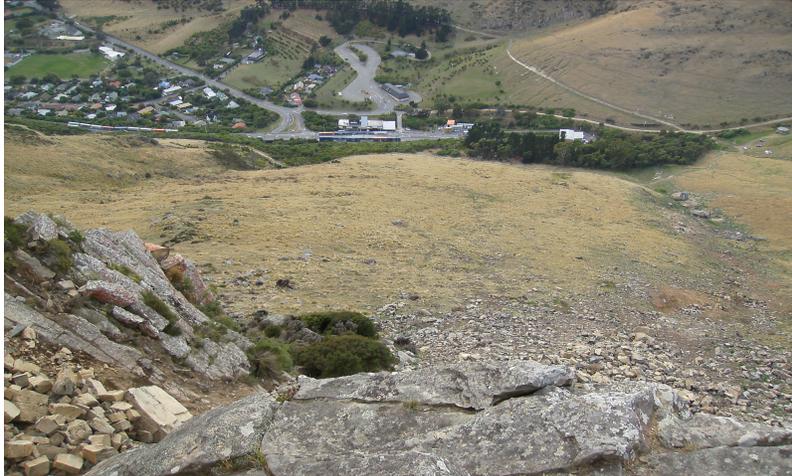
Figure 1. View from *Castle Rock* to northern tunnel portal with ballasted container temporary rockfall protection in place (post 22 February 2011).

As an immediate risk mitigation strategy, infrastructure at the highest levels of risk were either avoided (e.g. Heathcote Valley underpass closed and traffic diverted) or protected (e.g. main portal) by the strategic placement of ballasted shipping containers. Whilst these immediate actions permitted the re-opening of SH74 and the Lyttelton tunnel, the level of service was severely compromised and required significant levels of traffic management to ensure smooth and safe operation.

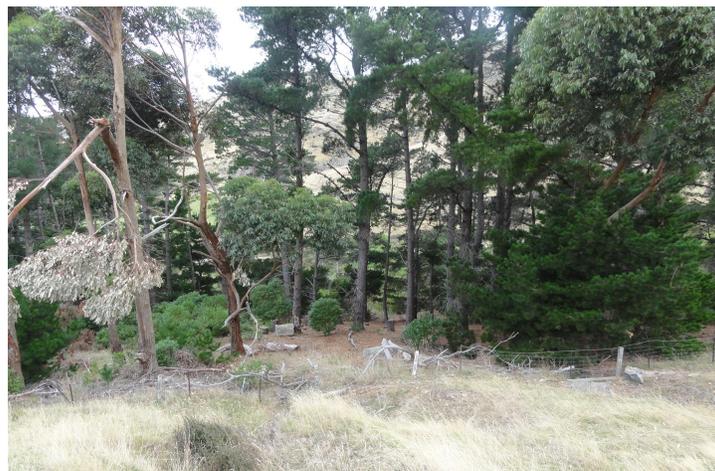
Figure 2. Shelterbelt to immediate west of tunnel northern portal with broken limb of tree indicating extreme bounce heights (post 22nd February 2011).

In contrast to the September 2010 event, the ground conditions (i.e. end of the southern hemisphere summer with very stiff to hard loess deposits) favored high energy rockfall ballistics (e.g. high velocities with correspondingly high bounce heights and energies). The outcome of these various conditions was a far greater number of boulders reaching the highway and supporting infrastructure, resulting in impact damage and elevated levels of Life Safety risk. In addition, previously inactive areas of the Port Hills surrounding the northern tunnel portal became active with respect to rockfall, and this subsequently changed the risk profile further.

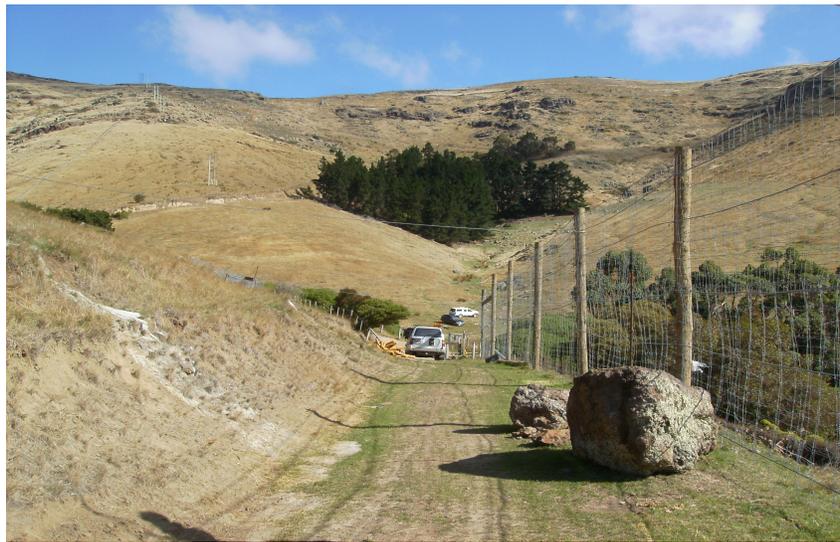
Figure 3. Part-complete temporary rockfall protection structures (post 22 February 2011).

Utilizing a benched access track around the northern tunnel portal, the rapid construction of a temporary, low-energy 4 m high catch fence was achieved. In total the catch fence was 450 m in length and was completed within a month. The temporary nature of the structure provided a medium-term solution yet reflected the uncertainty of the longer-term future.

In addition to the installation of temporary catch fences, the outcrop that had displaced causing the bolt and mesh system to exceed its ULS was deconstructed using targeted drill and blast techniques. This was undertaken following the completion of the catch fences. During the scaling phase at least one boulder of 0.5 m³ was arrested by the temporary catch fence providing an indication of its likely capacity and also its value.

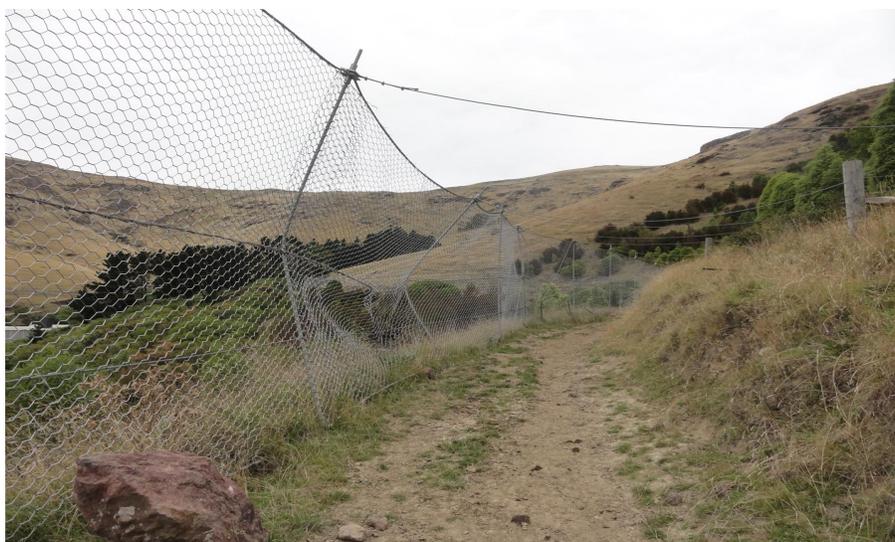
Throughout this period no further rockfall reached SH74. During the June 2011 aftershock further boulders were released from *Castle Rock* resulting in significant impacts to the catch fence, with one boulder impact at full height (3.5-4.0 m) causing the sacrificial supporting timber posts to fracture resulting loss in effective height. The boulder was arrested within a short distance of the catch fence.

Figure 4. Impacted and damaged temporary rockfall protection structures (post 22 February 2011).

This series of impacts validated construction of the temporary catch fence during a period of elevated seismic activity whilst a longer-term hazard management plan was established. Furthermore, the effectively ‘full scale field testing’ provided valuable information as to the likely capacity of the catch fence that could be taken forward into more detailed assessment throughout 2012.

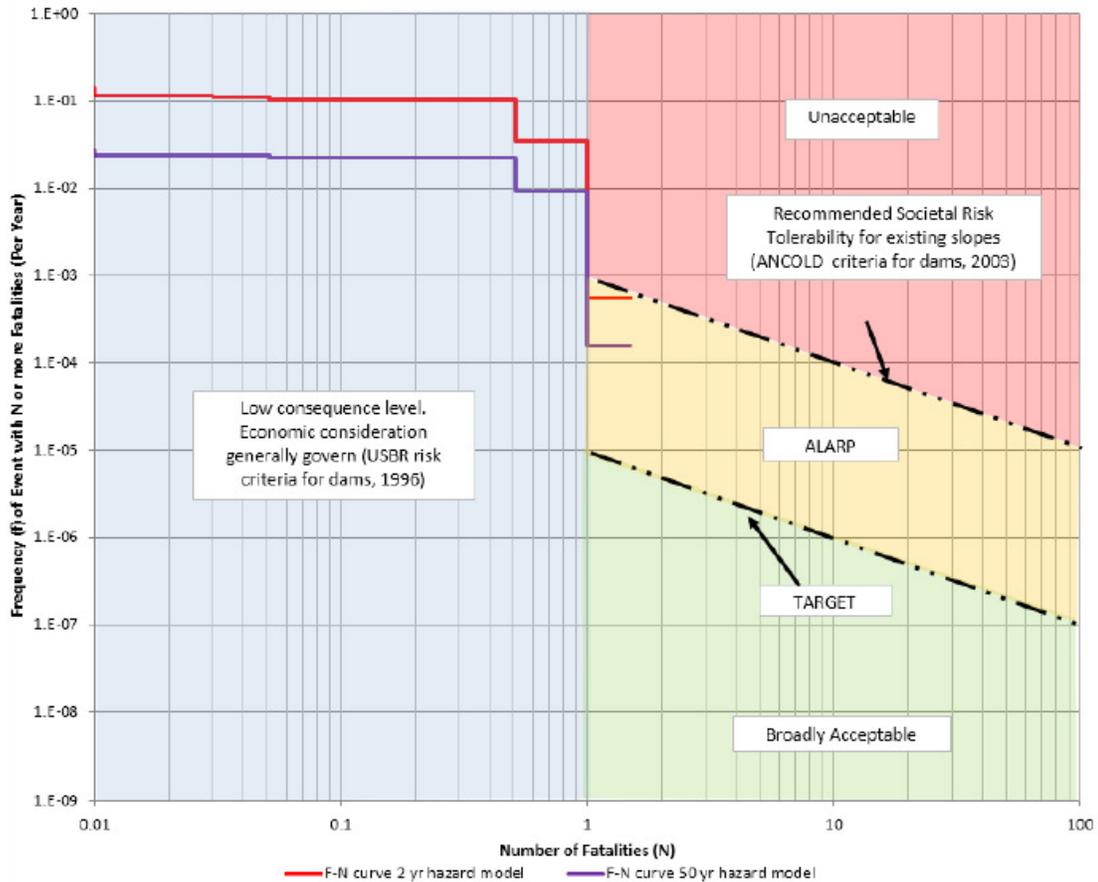
Current Rockfall Risk (due to EQ) - Plotted F,N cumulative risk

Figure 5. F(N) Plot and ALARP regions for quantitative rockfall risk (2 and 50 Year CSHM curves presented).

- Operational shift staff;
- The *Person Most At Risk* (PMAR); and,
- Societal risk using f(N) Pairs and F(N) Plots.

- Risks from rockfall to road users in the rockfall hazard zones were controlled to *Tolerable* levels and broadly in accordance with the ALARP (*As Low As Reasonably Practicable*) principle; and,
- Removal of rockfall protection structures would (in the short to medium-term) increase the rockfall risk levels to *Unacceptable* levels.
