# Earthquake-Induced Ground Fissuring and Spring Formation in Foot-Slope Positions and Valley Floor of the Hillsborough Valley, Christchurch, New Zealand

In the Hillsborough Valley of Christchurch, New Zealand, extensive loess soil fissuring and spring formation occurred following a series of local earthquakes in 2010 and 2011. Fissures were up to 800 m in length, contour-parallel and accompanied by lateral compression and spring formation in the valley floor. Soil compression likely led to the development of permeable pathways, allowing the upward migration of water resulting in springs. The spring water originates from volcanic bedrock, and has distinct rainwater contribution. The term “quasi-toppling failure” can describe the soil movement related to the fissuring, while the mechanism is a combination of the “trampoline effect”, the fault movement and bedrock fracturing, and “lateral spreading” which was exacerbated by intra-loess water coursing and tunnel gullying. Infiltration of water into the fissures has potential to cause further ground movement, and as such it is important that the all fissures are infilled to prevent water ingress.

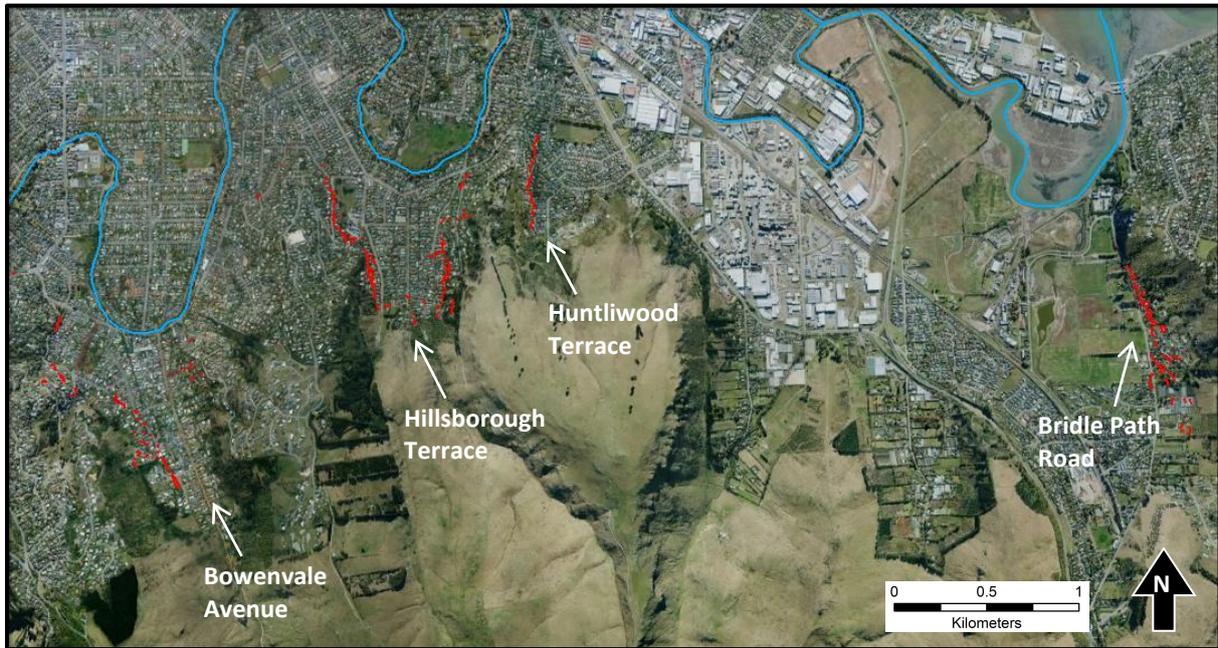
Figure 1: Overview map showing prominent fissure locations (fissure traces marked in red). Background imagery from Google Earth, 2012.

spring formation was observed following both the Darfield and Christchurch earthquakes, and the location of the springs has strong correlation to the location of ground deformation and fissuring. Figure 1 provides an overview map showing fissure locations. Earthquake-related spring formation was unprecedented in the Hillsborough Valley, with the formation of at least two dozen new springs. A map of the Hillsborough Valley showing fissure and spring locations, and the location of the lateral compression features, is provided in Figure 2.

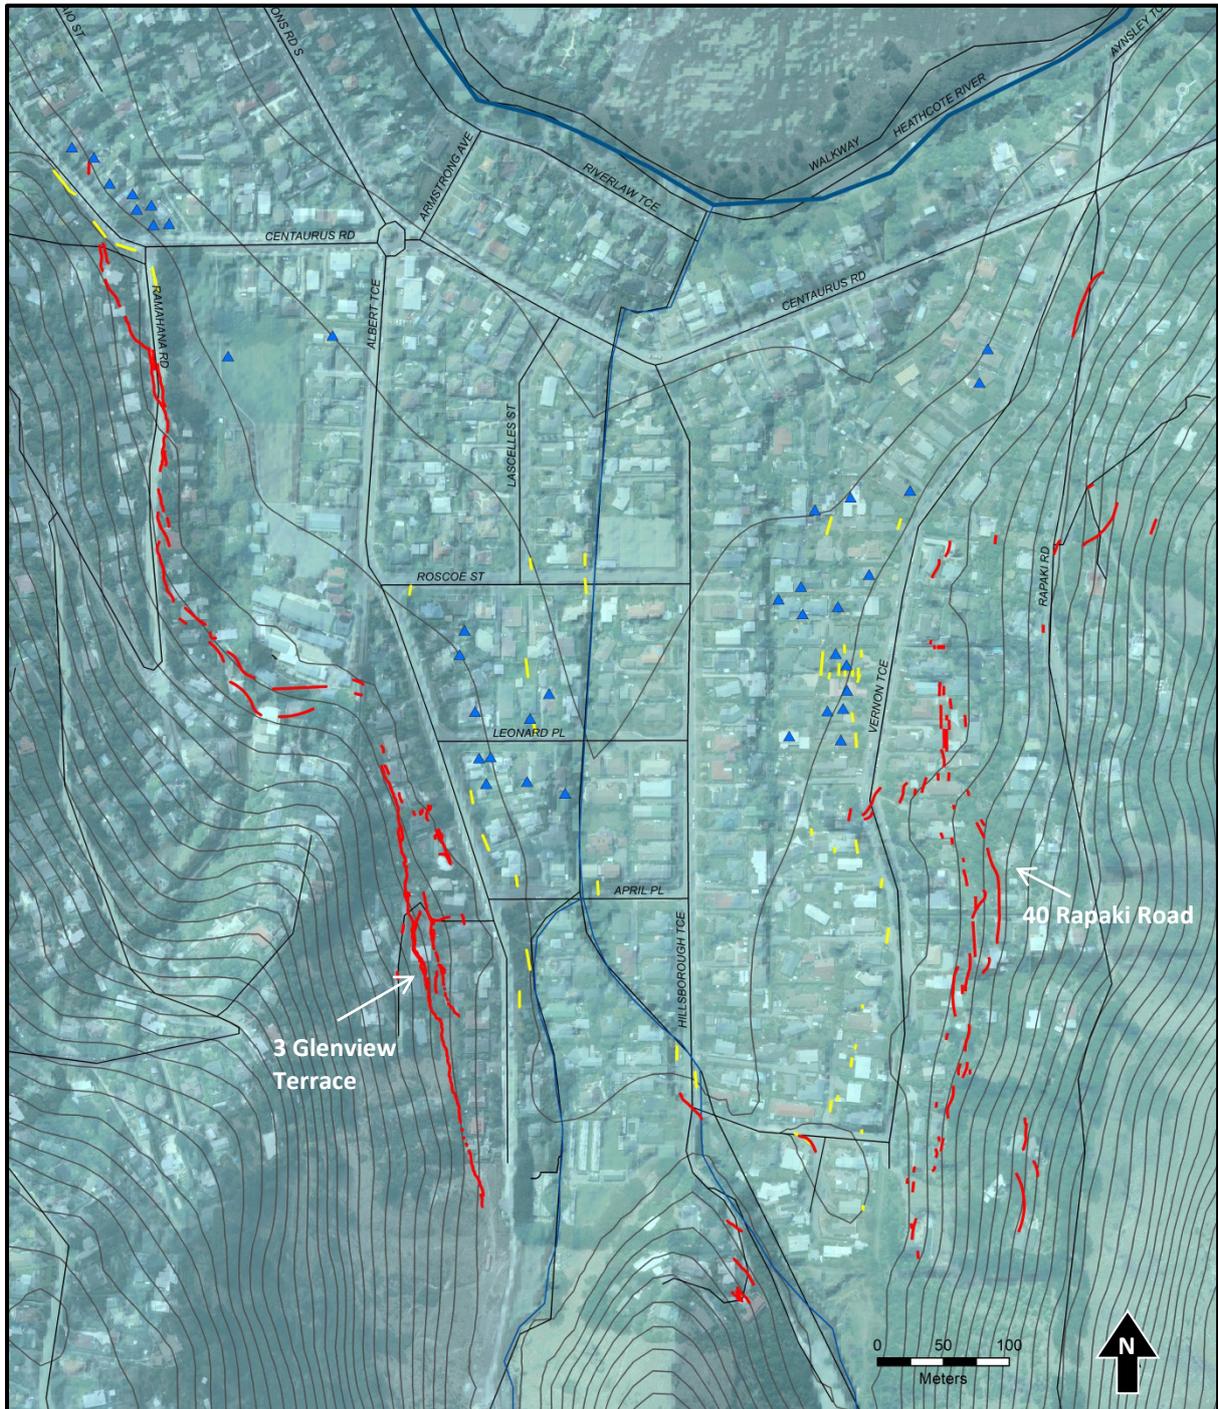
Figure 2: The Hillsborough Valley, showing fissure (red) and spring (blue) locations as well as compression zones (yellow). Contour intervals 5 m.

Rapaki Road on the eastern side (Figure 2). Fissures were generally contour-parallel, with only minor fluctuations in elevation. On the western side of the valley, a single continuous fissure (Figure 3) was mapped between Centaurus Road and upper Albert Terrace, with minor subsidiary fissures present to either side. The fissures on the eastern side of the valley (Figure 3) were more discontinuous in nature, and had a wider coverage of the hillside by the subsidiary fissures.

Formation of springs and seepages in valley floors of the Port Hills occurred contemporaneously with both the Darfield and Christchurch Earthquakes. Springs in the Hillsborough Valley formed in close proximity to the valley floor compression features (Figure 2). Three clusters of springs formed in the valley; one where Ramahana Road meets Centaurus Road (near 211 Centaurus Road); another at the junction of Albert Terrace and Leonard Place; and a third centrally located on the western side of Vernon Terrace (spring locations by H. Rutter, Aqualinc, pers. com. 2012).

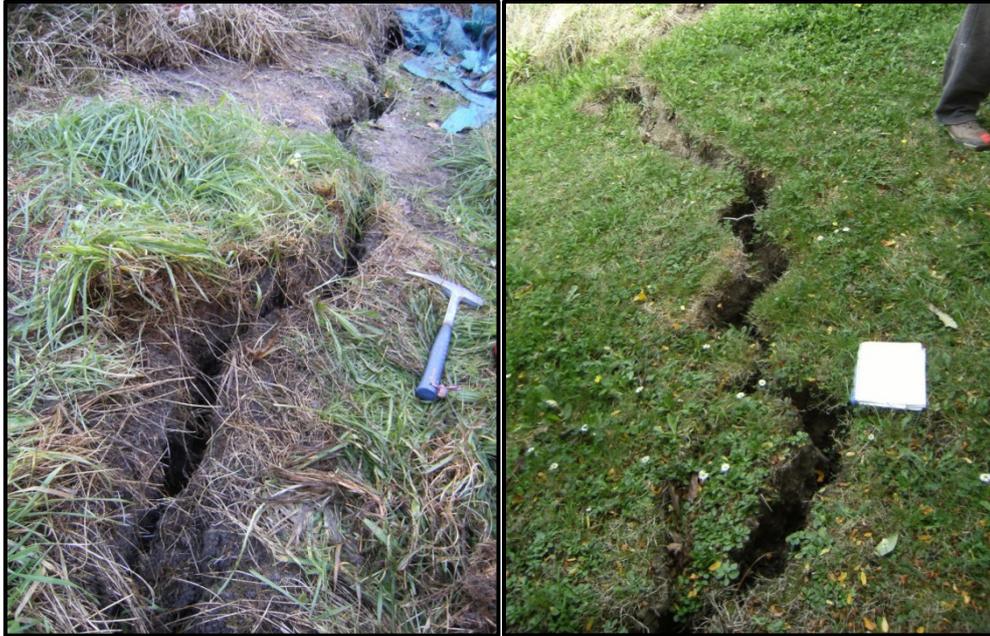
Figure 3: Ground fissuring at number 40 Rapaki Road (left) and number 3 Glenview Terrace (right). Both photographs taken facing south towards the head of the valley. Geological hammer and A4-size paper for scale.

The fissure traces were alike in appearance at any given location along the fissure trace. There was always some lateral extension (up to 0.2 m) and usually the down-slope side of the fissure trace dropped by up to 0.15 m. Loose soil frequently fell into the base of the fissure; however it was usually possible to extend a rigid tape measure into the fissure by over 1 m, and occasionally to depths of greater than 5 m. Only two instances where the down-slope side

of the fissure was higher with respect to the up-slope side (by approximately 0.10 m) were observed. These were at 3 Glenview Terrace and 44a Rapaki Road. Melt-water from heavy snowfall in Christchurch in 2011 caused a large collapse of loess at 3 Glenview Terrace, as the fissure system appeared to link up to subterranean tunnel gullying.

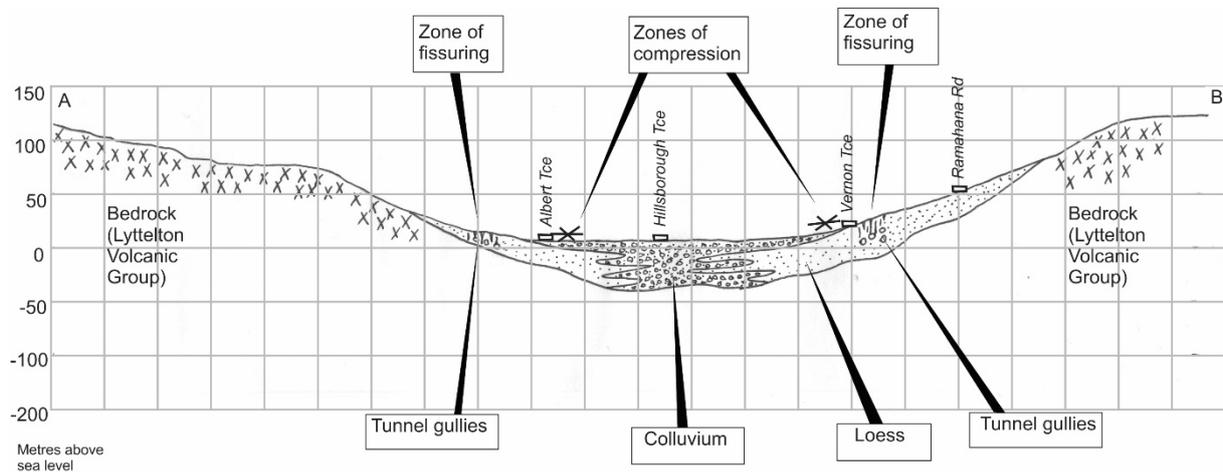
Figure 4: Schematic profile of the Hillsborough Valley, facing northwards.

When overlaid onto the geologic map of Christchurch by Brown & Weeber (1992), the fissure traces coincide approximately with the boundary between the bedrock-mantling loess deposits and the colluvial valley fill. In the field it was observed that in most locations the fissures appear at least 20 m (overland distance) below the beginning of outcropping bedrock. Figure 4 shows a schematic cross section through the centre of the Hillsborough Valley, showing the location of the fissure traces and soil types.

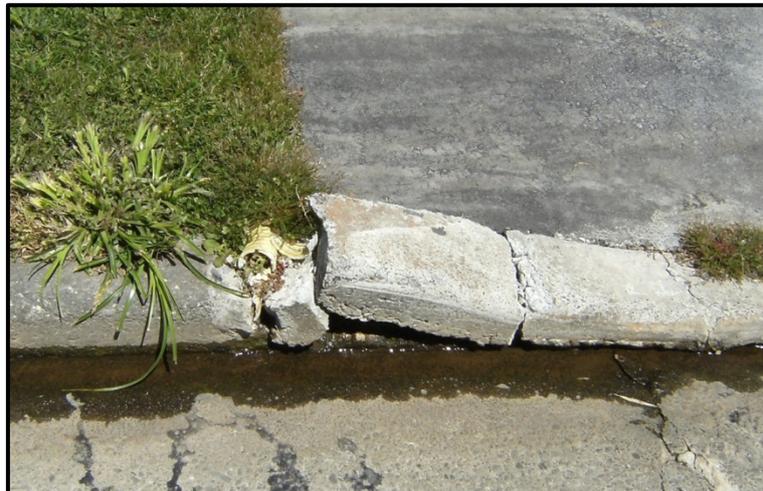
Figure 5: Kerbing in Roscoe Street. Such evidence of lateral compression was observed in kerbing at many sites in east-west oriented streets in the Hillsborough Valley floor.

Nearly every section of fissure trace with measureable extension was accompanied by lateral compression features in the valley floor below. The extent of compression was comparable to the total lateral extension in the fissures above. In most of the east-west oriented streets in the Hillsborough Valley, lateral compression was seen in kerbing on the roadside. For example, a plastic outlet pipe in Roscoe Street created a weaker zone in the concrete kerbing, which encouraged compression to be focused in that location (Figure 5).

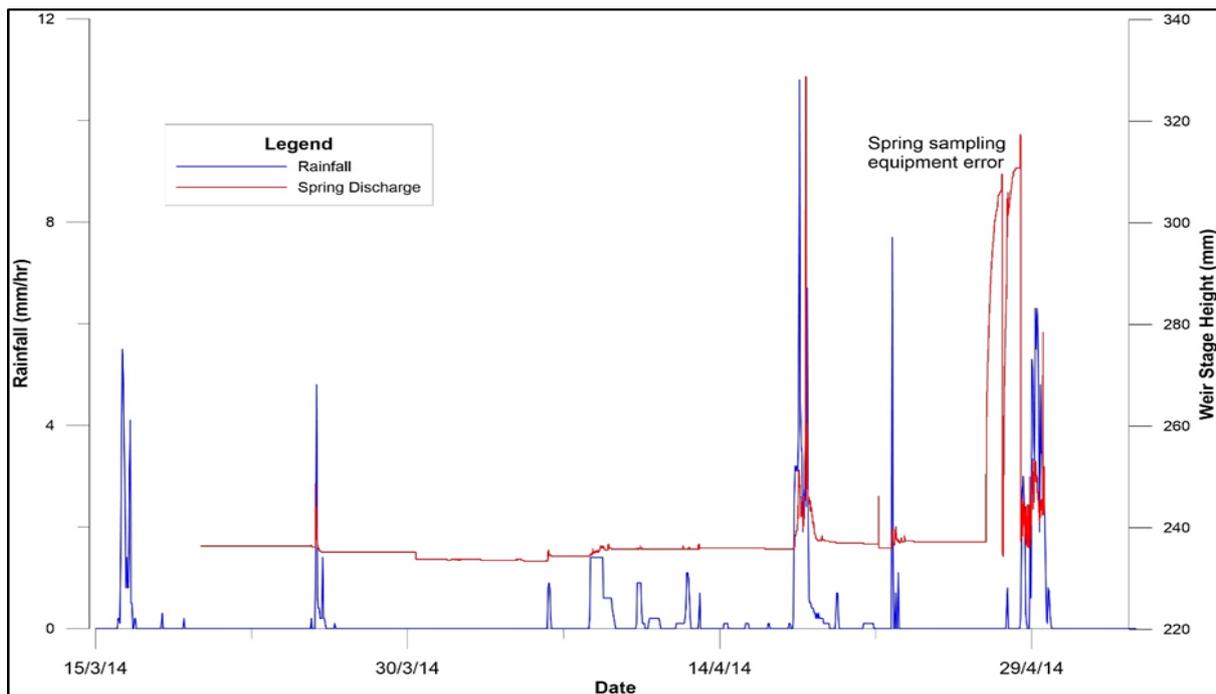
Figure 6: Spring discharge and rainfall volumes during April 2014, at 10 Vernon Terrace.

The weir was installed by Aqualinc beneath 10 Vernon Terrace, and it is noted that the apparent pre-rainfall spike in spring discharge around the 29th of April 2014 was caused by sampling equipment error.

Spring water analysis shows a “base flow” of spring water that originates from volcanic (mostly basaltic) bedrock, with a strong rainwater input during storm events. Measured chloride concentrations from springs on Vernon Terrace range between 20 mg/l and 271.6 mg/L, sulphate levels range between 50 to 60 mg/L and Oxygen Stable Isotope values for the spring water range from -7.9 to -8.2  $\delta^{18}\text{O}$  (V-SMOW). These values correlate with Bank Peninsula bedrock derived groundwater (Brown and Weeber 1994). Rainwater collected in the area had much lower concentrations of chloride ranging from 0.2-15.9mg/l. Spring water chloride concentrations decreased following rainfall events. Both the groundwater piezometer and spring discharge analyses show fluctuations with strong correlation to rainfall events (Figure 6).
