Stability Monitoring of Earthquake-Induced Slope Failure and Landslides

ABSTRACT

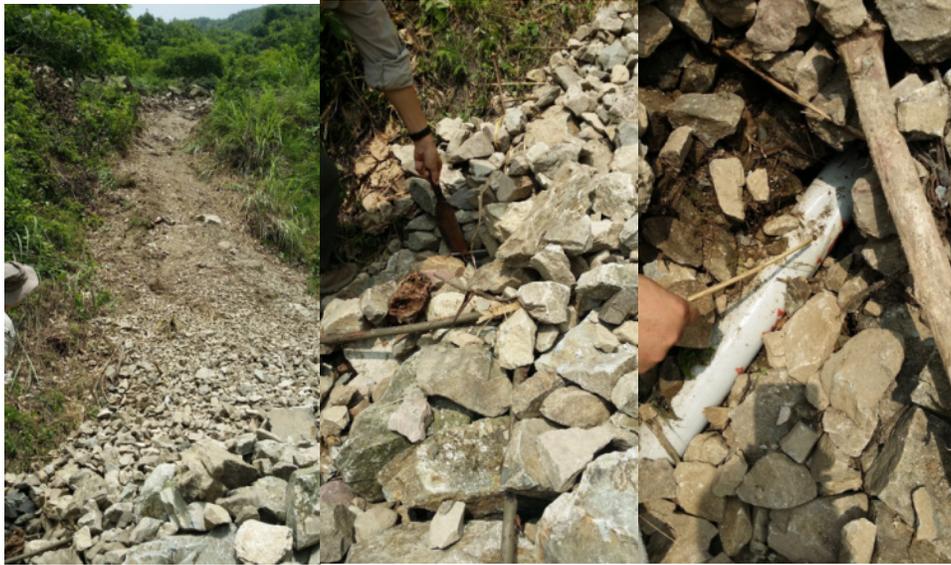
Figure 4. Wireless sensor unit destroyed by suddenly slope failure or rockfall flow

A small-scale slope failure suddenly occurred at the position of wireless sensor unit K-1 on July 6, 2013, without an accompanying increase in rainfall. Another two wireless sensor units maintained normal operations. The site manager became aware of the abnormal behavior from the wireless sensor, and traveled to the field site. He found that the wireless tilt sensor of unit K-1 was completely buried (Figure 4).

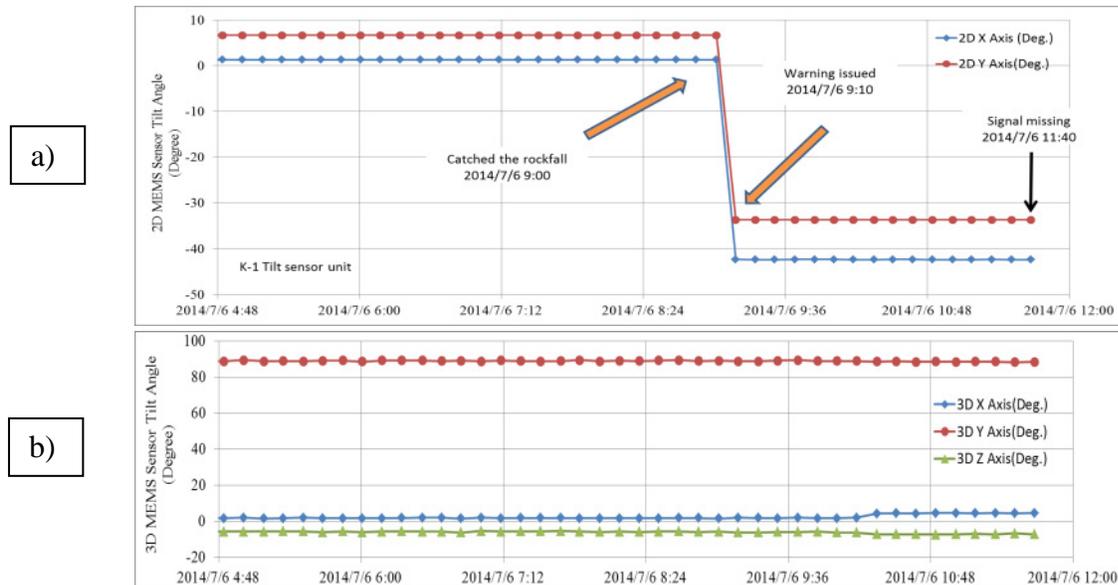
Figure 5. Real time data for sensor unit K-1 around the time of slope failure.

Figure 5 a) shows how the inclination of the 2D MEMS embedded in the separated tilt sensor unit changed over time, and Figure 5b) shows the relationship between the 3D MEMS inclination and time. On this slope, the real-time monitoring system started with three sensor units (Figure 1) 3 months earlier. No rain fell during the collapse of the slope. At 9:00 on July 6, the system showed that the tilt angles of the X and Y axes had notable changes. The output voltages of the 2D MEMS tilt sensor unit reached their limited, which means that the cable that connected the sensor and wireless units had become disconnected or broken, i.e., the separated 2D MEMS tilt sensor unit was destroyed by the first stage of slope failure or rock flow. At this time, the wireless unit continuously transferred the 3D MEMS tilt data, as is normal, to the remote data center. In other words, the system gave us a lot of time, more than 5 hours, to send out warnings.
