## Over-turning of a building with pile foundation - combined effect of liquefaction and tsunami

T. Tobita<sup>1</sup>, and S. Iai<sup>2</sup>

### ABSTRACT

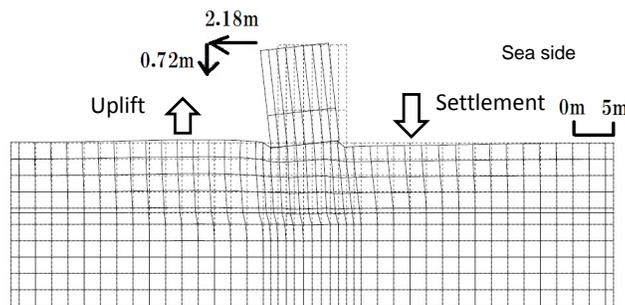
Figure 8. Before and after deformation

To visualize the stress distribution in the ground near the building, effective stress analysis was conducted using FLIP/TULIP (Ver.6.1.0) (Iai et al. 2013a 2013b, Iai et al. 2013c). In the analysis, the multi-spring element (Cocktail glass model) was implemented as an elasto-plastic constitutive relationship of soil. In the analysis, the model parameters shown in Table 2 to Table 5 were adopted. The prototype used in the centrifuge experiment was analyzed as shown in Fig. 7. Because the numerical method adopted in the study has no option to simulate water flow such as a tsunami, the hydrostatic force converted from tsunami height (6.0 m) was applied (Fig. 7). The thrust force applied on the side of the caisson corresponds to the hydrostatic force determined by assuming 3 times the water depth due to the tsunami (OCDI 2009). The hydrostatic force corresponding to a water depth of 6 m was  $u$  at the surface of the sea facing section. Using this method, ground water flow could be simulated. In the analysis, the forces shown in Fig. 7 were gradually increased to simulate the arrival of the tsunami. As a result, shown in Fig. 8, the sea facing side settled while the inland facing side uplifted due to ground water flow, and the building was tilted as indicated in the figure.

Results of the numerical analysis indicated that the excess pore water pressure ratio under the building markedly increased on the sea facing side because of uplift of the foundation associated with rotation of the building. This implies that the ground near the surface under the building remained liquefied and, therefore, became vulnerable to scouring.
