New Reinforcing Technique for Mitigation of Earthquake-induced Failure of Breakwater

B. Chaudhary¹, H. Hazarika², N. Monji³, T. Hara⁴, K. Nishimura⁵, K. Kasama⁶ and R. Ishikura⁷

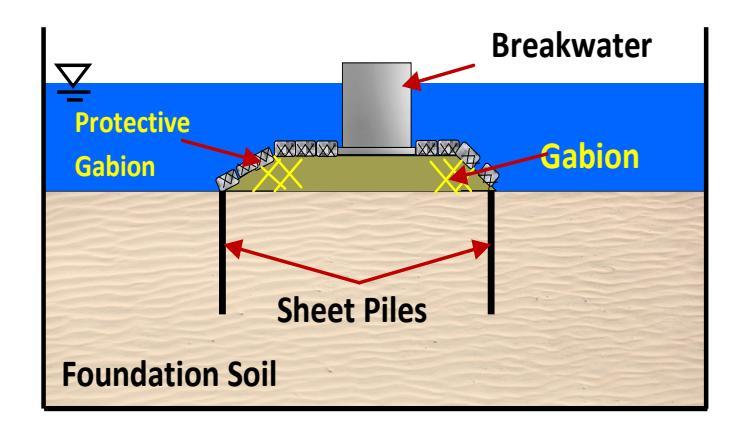
Figure 1. New reinforcing foundation technique for a resilient breakwater

As a counter measure, a new reinforcing technology is proposed for foundation of breakwater. In place of rubble mound, gabion mound foundation was used and protective gabion was adopted to cover entire mound as shown in Fig. 1. The gabion mound can protect the mound from scouring effect of tsunami waves and improve bearing capacity of the foundation due to its confinement characteristics. Lateral displacement and subsidence of the breakwater can also be controlled due to these properties. In addition to gabion, two rows of sheet piles were installed in the foundation as shown in Fig. 1. As the sheet piles can behave like cut off walls and thus can reduce seepage flow of water below the foundation during tsunami and reduce uplifting force due to seepage of water. The sheet pile can restrict lateral deformation of the foundation soils due to rigidity characteristics, and can reduce deformation of the foundation. The sheet piles can also reduce scouring of the foundation soils during tsunami (both leading wave and backrush). A series of shaking table tests and numerical analyses were performed to evaluate the effect of the proposed reinforcing technique on performance of the breakwater against earthquake.

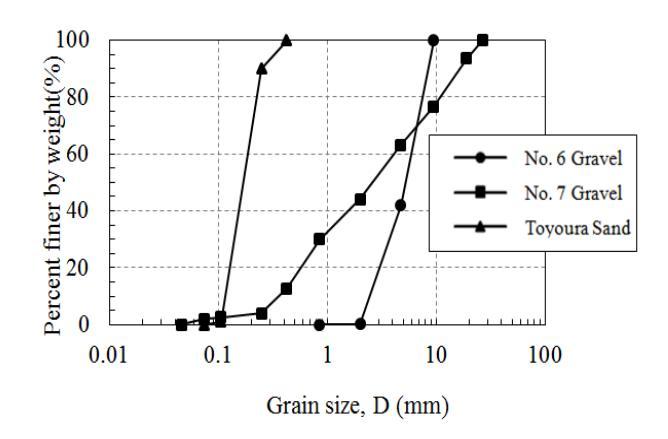
Figure 2. Grain size distribution curve of the materials used in the test

In the research, the breakwater at Miyazaki port (Miyazaki Prefecture, Japan), which is likely to be affected by the predicted Nankai trough earthquake, was chosen as a prototype. Prototype to model ratio was 64 for the test, and similitude relationship proposed by Iai (1989) was adopted to determine the various parameters, which are shown in Table 1. Soil box was made with acrylic plates and steel frames. Model of caissons (breakwaters) were made of aluminum and filled with silica sand and lead balls to adjust weight and center of gravity. One main caisson at center and two dummy caissons (one dummy caisson on both side of main caisson) were used in the test. The dummy caissons were used to reduce effect of sand box (e.g. side friction between main caisson and sand box) on the performance of the breakwater. All instrumentations were done for the central caisson. Sheet pile was made of steel plate (200 mm height, 400 mm width and 3.2 mm thickness). The thickness of the sheet pile was determined by adjusting stiffness to prototype. The foundation of the breakwater was made of Toyoura sand (relative density, $D_r = 60\%$). The rubble mound was made of number 6 gravel. The protective gabion was made of number 7 gravel and wrapped with wire mesh of steel wire (diameter = 0.63 mm). The dynamic characteristics of sand and gravels against cyclic loading were determined through element testing which is reported in Hazarika et al. (2014). Grain size distribution curves of foundation materials are shown in Fig. 2. Properties of foundation materials are shown in Table 2.

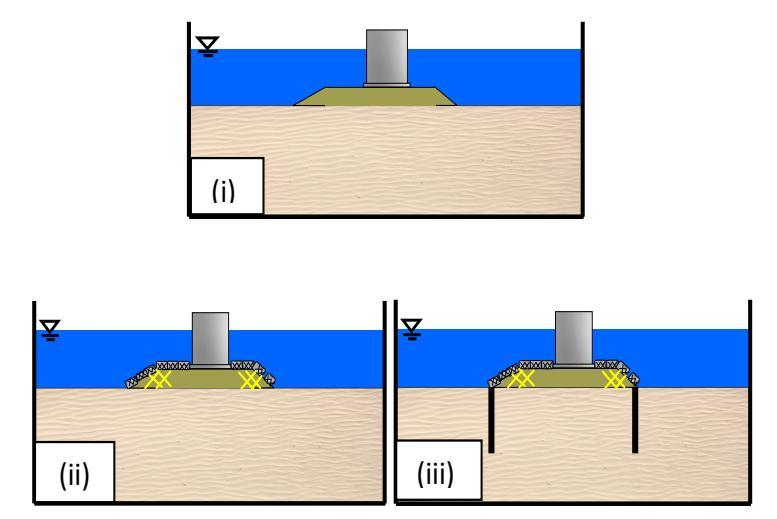
Figure 3. Layouts of the models (i) Unreinforced breakwater foundation, (ii) Breakwater foundation reinforced with gabion only, and (iii) Breakwater foundation reinforced with combined reinforced (gabion and two rows of sheet piles together)

Three different models of breakwater were used in the test as shown in Fig. 3: (i) Conventional breakwater foundation (unreinforced foundation), (ii) Breakwater foundation reinforced with

gabion only and (iii) Breakwater foundation reinforced with combined reinforcement (gabion and two rows of sheet piles together). Instrumentations for shaking table test is shown in Fig. 4, two laser displacement gauges (L-1 and L-2,) and two displacement gauges (D1 and D2) were installed to monitor settlements and horizontal displacements of the caisson respectively. Seven accelerometers (A1 to A7) were used to record accelerations. Four water pressure gauges (W41 to W44) were installed to measure water pressures on the breakwater, and eight pore water pressure gauges (W11 to W33) were installed to monitor pore water pressures in the foundation.

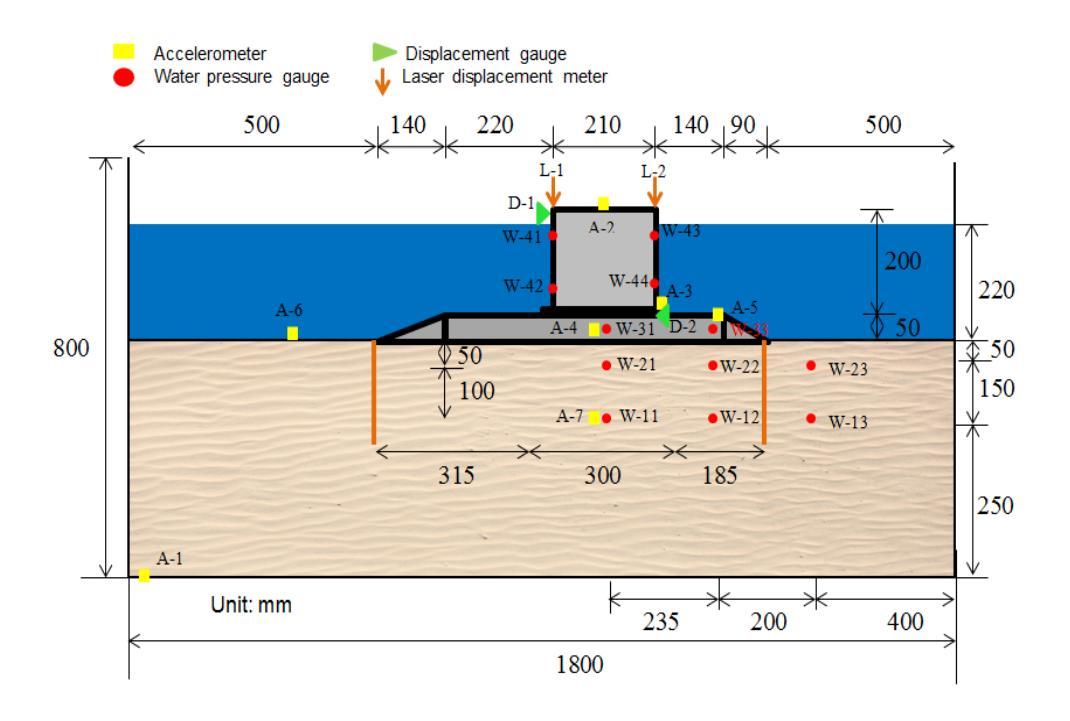
Figure 4. Instrumentations for the shaking table test

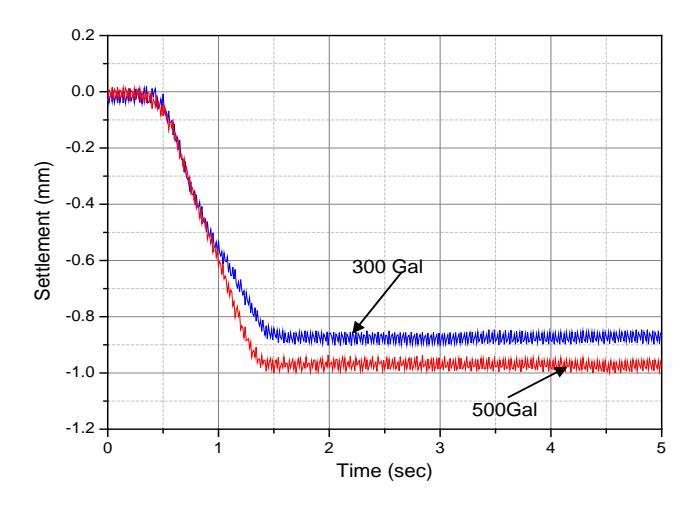
Figure 5. Settlement of caisson for unreinforced foundation at L-1 for different accelerations (300 Gal and 500Gal) and same continuation time (1 second)

In order to determine the effect of different magnitudes of accelerations of dynamic loadings on the performance of the breakwater, settlement of the caisson at L1 (top left corner) of the caisson was measured under earthquake loading of different acceleration magnitudes (300 Gal and 500 Gal) and same continuation time (1 second), and is shown in Fig. 5. It can be seen that settlement increases with increase in acceleration magnitude. For 300 Gal, residual settlement of the caisson was 0.9 mm and that increased to 1.0 mm for 500 Gal.

The settlements of the caisson at L1 for unreinforced and combined reinforcement foundation are shown in Fig. 5 and 6 respectively. It can be noticed that settlement reduced for reinforced foundation. The settlement of reinforced foundation is 33% and 20% less than unreinforced foundation at 300 Gal and 500 Gal respectively. Probably due to confinement effect of gabion and rigidity characteristics of sheet piles, settlement of the caisson reduced.

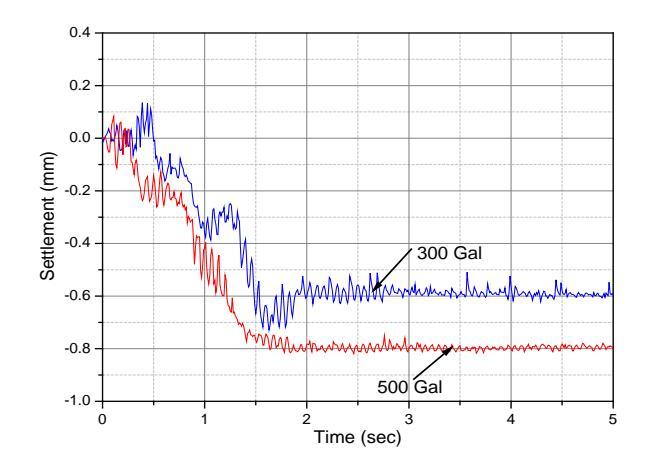
Figure 6. Settlement of caisson for combined reinforced foundation at L-1 for different accelerations (300 Gal and 500 Gal) and same continuation time (1 second)

The settlement for the foundation reinforced with combined reinforcement measured at L-1 of the caisson under earthquake loading of different acceleration magnitudes (300 Gal and 500 Gal) with same continuation time 1 second, and is shown in Fig. 6. The residual settlement of the caisson increases with increase in acceleration. The settlement was 0.6 mm and 0.8 mm for 300 Gal and 500 Gal respectively. The increase in settlement was found 33% when acceleration increases from 300 Gal to 500 Gal.

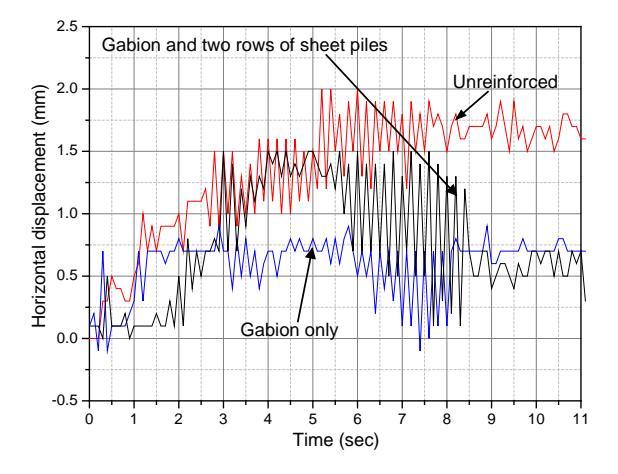
Figure 7 Horizontal displacement of caisson measured at D-2 for earthquake loading (300 Gal-8 Second).

Fig. 7 shows horizontal displacement of the caisson measured at D-2 (bottom right corner of the caisson) for earthquake loading (300 Gal-8 Second). The reinforced foundation shows less horizontal displacement than unreinforced foundation. The gabion reinforced foundation and combined reinforced foundation shows almost similar residual horizontal displacement. Residual horizontal displacement for the reinforced foundation was reduced by about 41% compared to the unreinforced foundation. The excess pore water pressure measured at W-12 (300 Gal-8 Second), and is shown in Fig. 8. The unreinforced foundation and gabion reinforced foundation shows almost similar excess pore water pressure, but the combined reinforced foundation shows less excess pore water pressure during earthquake loading.

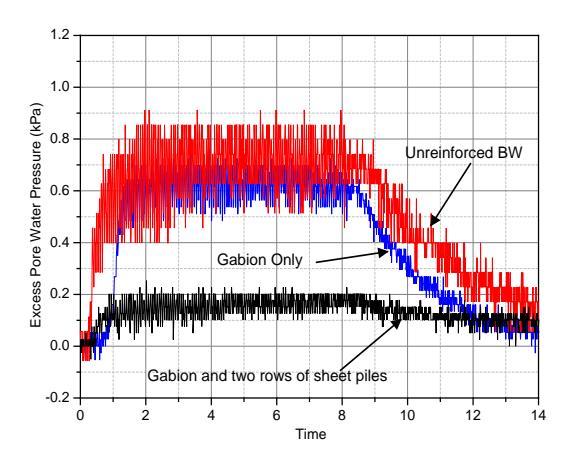
Figure 8. Excess pore water pressures in the foundation at W-12 for earthquake loadings (300 Gal-8second)

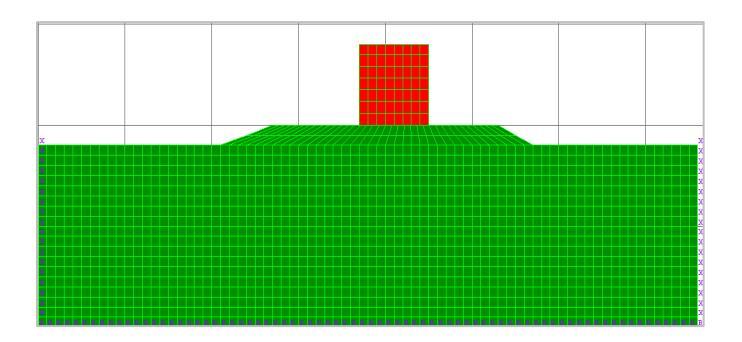
Figure 9. Numerical model of unreinforced breakwater

The sea bed was modelled as cohesionless material with elastic plastic response with Mohr-Coulomb failure criterion. For liquefaction behaviour of sea bed, the formula proposed by Byrne (1991) was used in the analysis. The breakwater was modelled as elastic material. Fixed boundary conditions were applied at both end sides of the model during the dynamic loadings. The numerical model was made similar to that of shaking table test. A damping ratio of 5% was assigned to the model. Dynamic loading in the form of sinusoidal waves of acceleration 400 Gal, time 8 second and frequency 15Hz were applied to the model. The numerical model of unreinforced breakwater foundation is shown in Fig. 9. The shear strain distribution for unreinforced breakwater foundation at the end of dynamic loading is shown in Fig. 10. It can be seen that strain below the left and right corner of the caisson is high. The soil below the left and right corner of the shaking table tests also.

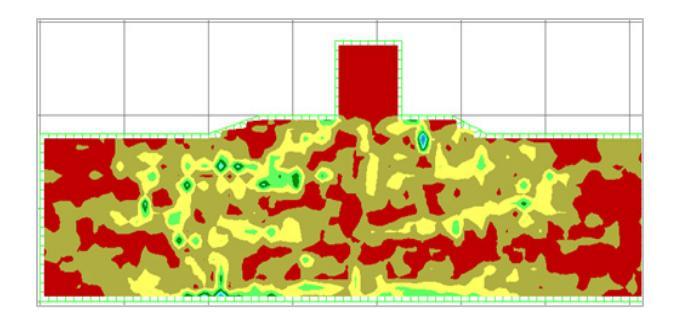
Figure 10. Shear strain distribution within the mound and the foundation soils

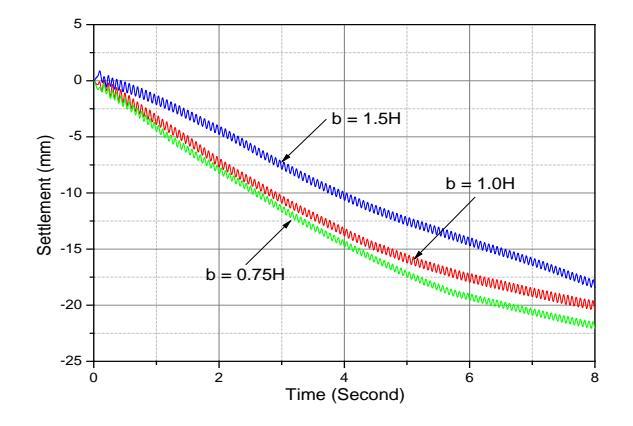
Figure 11. Settlement of the caisson for different width of the caisson

In order to evaluate the effect of width (b) of the caisson, settlement and horizontal displacement of the caisson were measured for different width (b = 0.75H, 1.0H and 1.5H, where H= height of the caisson) of the caisson. The settlement of the caisson measured at top right corner of the caisson, and is shown in Fig. 11. It can be seen that settlement increases with decrease in width of the caisson. The horizontal displacement of the caisson measured at bottom right corner of the caisson, and is shown in Fig. 12 for unreinforced foundation. It can be observed that the horizontal displacement is almost similar for b = 1.50H and 1.00H (H = height of the breakwater) but for b = 0.75H, the horizontal displacement is more than other cases.

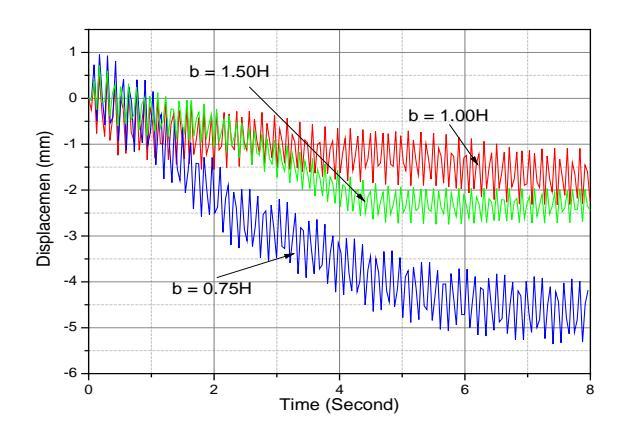
Figure 12. Horizontal displacement of the caisson for different width of the caisson
