Midstream of Kiso river affected by Tensho mega-earthquake

ABSTRACT

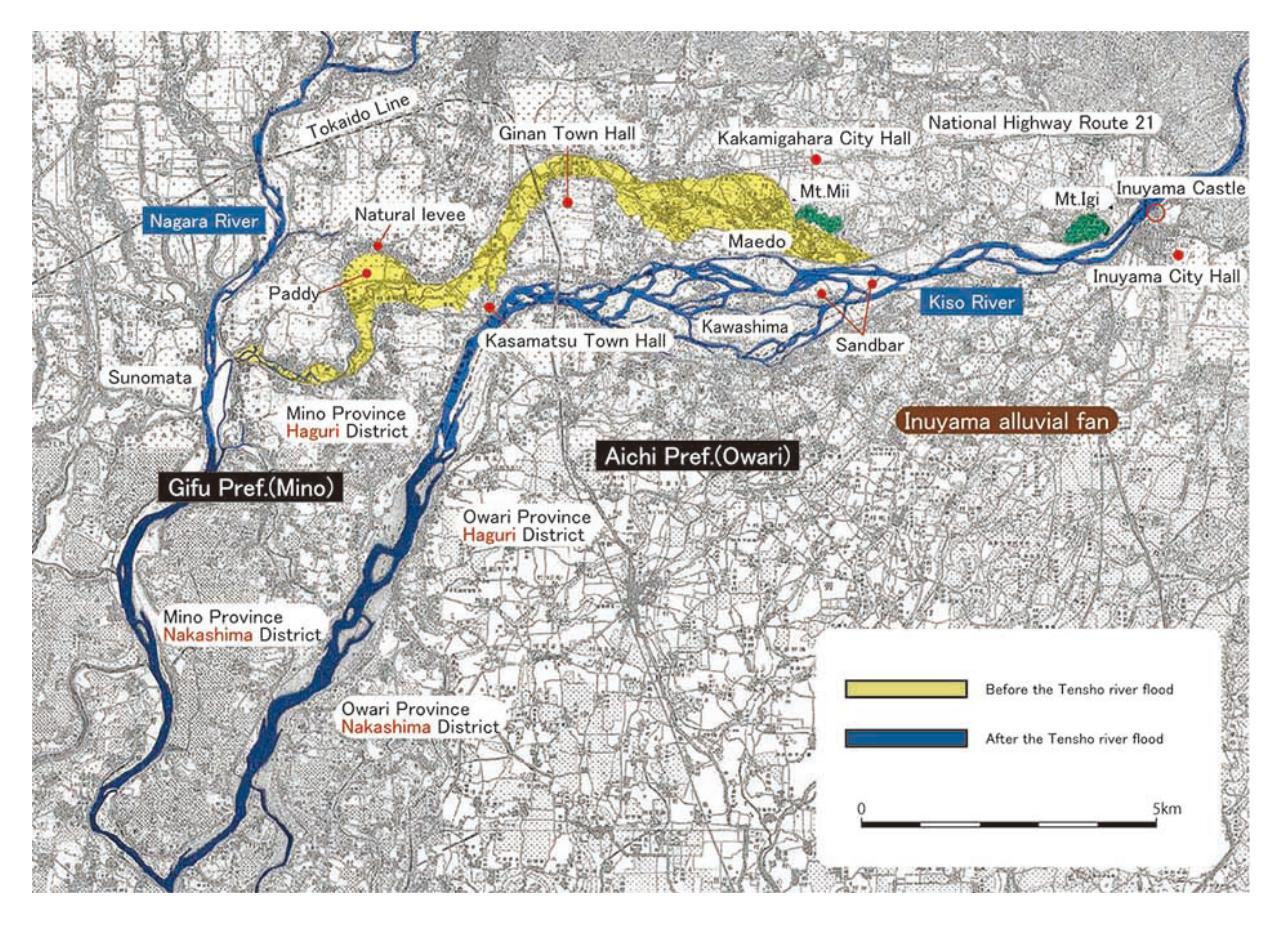
Figure 2. Kiso passage before and after the Tensho river flood(1586).

The old watercourse of Kiso River before 1586 was estimated as shown in Fig.2 which was created based on a topographic map made in 1891 (K.S.R.C,2004). The old terrain was left in the topographic map made in the 1890s because the ground development in the 1890s had not progressed like present.

The old watercourse of Kiso River might flow to the northwest around Mt. Mii and connected to Nagara River in Sunomata while meandering large. It is clear that the private houses stand on the natural levee along the old watercourse of Kiso River and the old riverbed is used as paddy field.

Judging from the above-mentioned transition of the place names, the watercourse of old and new Kiso River shown in Fig.2 will be reasonable in most.

The watercourse of Kiso River is freed from a ravine zone at the vicinity of Inuyama castle. Also, the complicated history of watercourse in the downstream of Kiso River can be recognized from Fig.2. In the Pleistocene epoch, deposition and erosion had been repeated on the Nobi Plain due to a change of the sea level. A wide Inuyama alluvial fan of about 12 km radius was formed in the Nobi Plain at the Postglacial Age after the Pleistocene. Kiso River gave a great influence on the terrain formation in the region shown in Fig.2. While Kiso River had left plural branches on the alluvial fan during the historic times, the mainstream had gathered into two watercourses to the west at the north side of the alluvial fan, which were the northern channel and southern channel of Kiso River.

When the terrain inclination of the southern channel after Tensho river flood is studied, it is noteworthy that the watercourse of the southern channel extends in a straight line from Kasamatsu town hall to the southwest direction as shown in Fig.2. There is no meander in the watercourse at the above-mentioned straight part and the flow at this part seems to be more quantity and faster velocity. It has come to the inference that the main reason of watercourse alteration into the southern channel is due to a change in the terrain inclination.

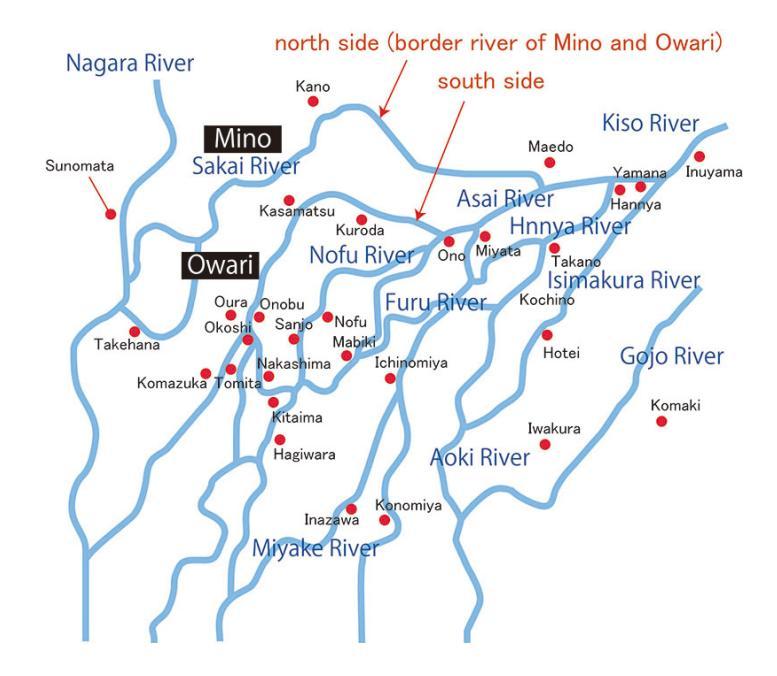
Figure 3. Kiso passage of Tensho14(1891) previous.

The old watercourse of Kiso River before 1586 had branched complicatedly as shown in Fig.3(Nakajima,T.Nakajima,K.1963). Among those branches, two branches of the northern channel and southern channel were considered as the main watercourse of old Kiso River. The northern channel of old Kiso River was blocked during the Tensho river flood. As a result of the Tensho river flood, the flowing water of old Kiso River was concentrated into the southern

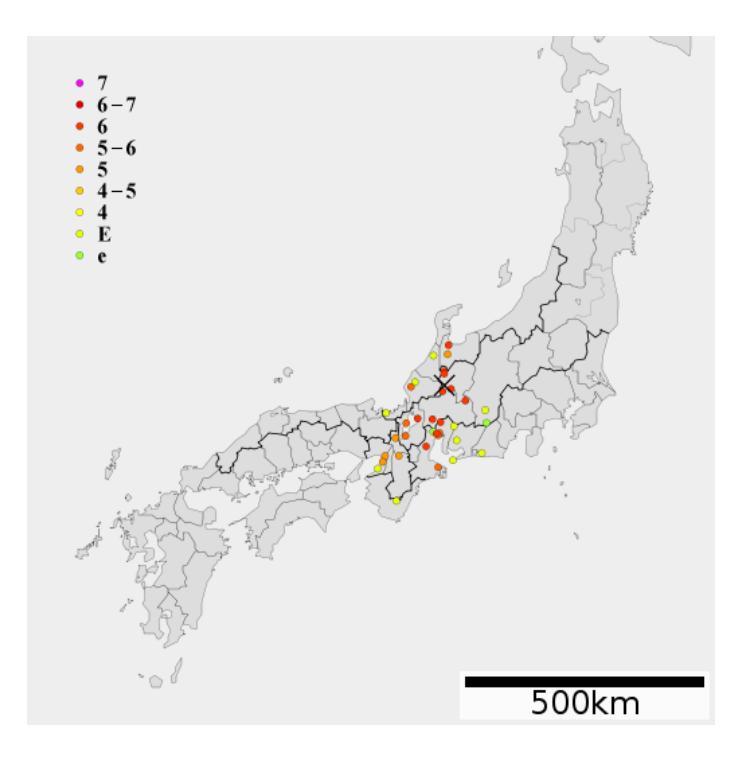
Figure .4 Seismic intensity distribution diagram of Tensho earthquake.

The Tensho mega-earthquake was a massive earthquake occurred at the Chubu region in Japan on 18th January 1586 (= 29th November, Tensho 13). The Tensho mega-earthquake was also called Nagahama mega-earthquake in Shiga prefecture, Hakusan mega-earthquake in Ishikawa prefecture and Gifu prefecture, Kibune mega-earthquake in Toyama prefecture, Tenyu mega-earthquake in Mie prefecture, etc. The focal region and magnitude of the Tensho mega-earthquake has not been clear yet. Because, the Tensho era was the end of Warring States Period and the Shogun administration did not function to collect the information of calamity. Therefore, the old various records of the earthquake written by Samurais, monks, oracles, etc. were collected and presumed a distribution of seismic intensity etc. (see Fig.4) as below (Usami,1994).

The focal region of the Tensho mega-earthquake exerted on the wide range of Kinki, Hokuriku and Tokai regions, namely the present Fukui, Ishikawa, Aichi, Gifu, Toyama, Shiga, Kyoto, Nara and Tokushima prefectures. It has been reported a tremendous damage to these areas. By comparing the range of damage, the Tensho mega-earthquake is estimated to exceed the Nobi earthquake (M8.0 - 8.4 in Richter scale) in 1891.

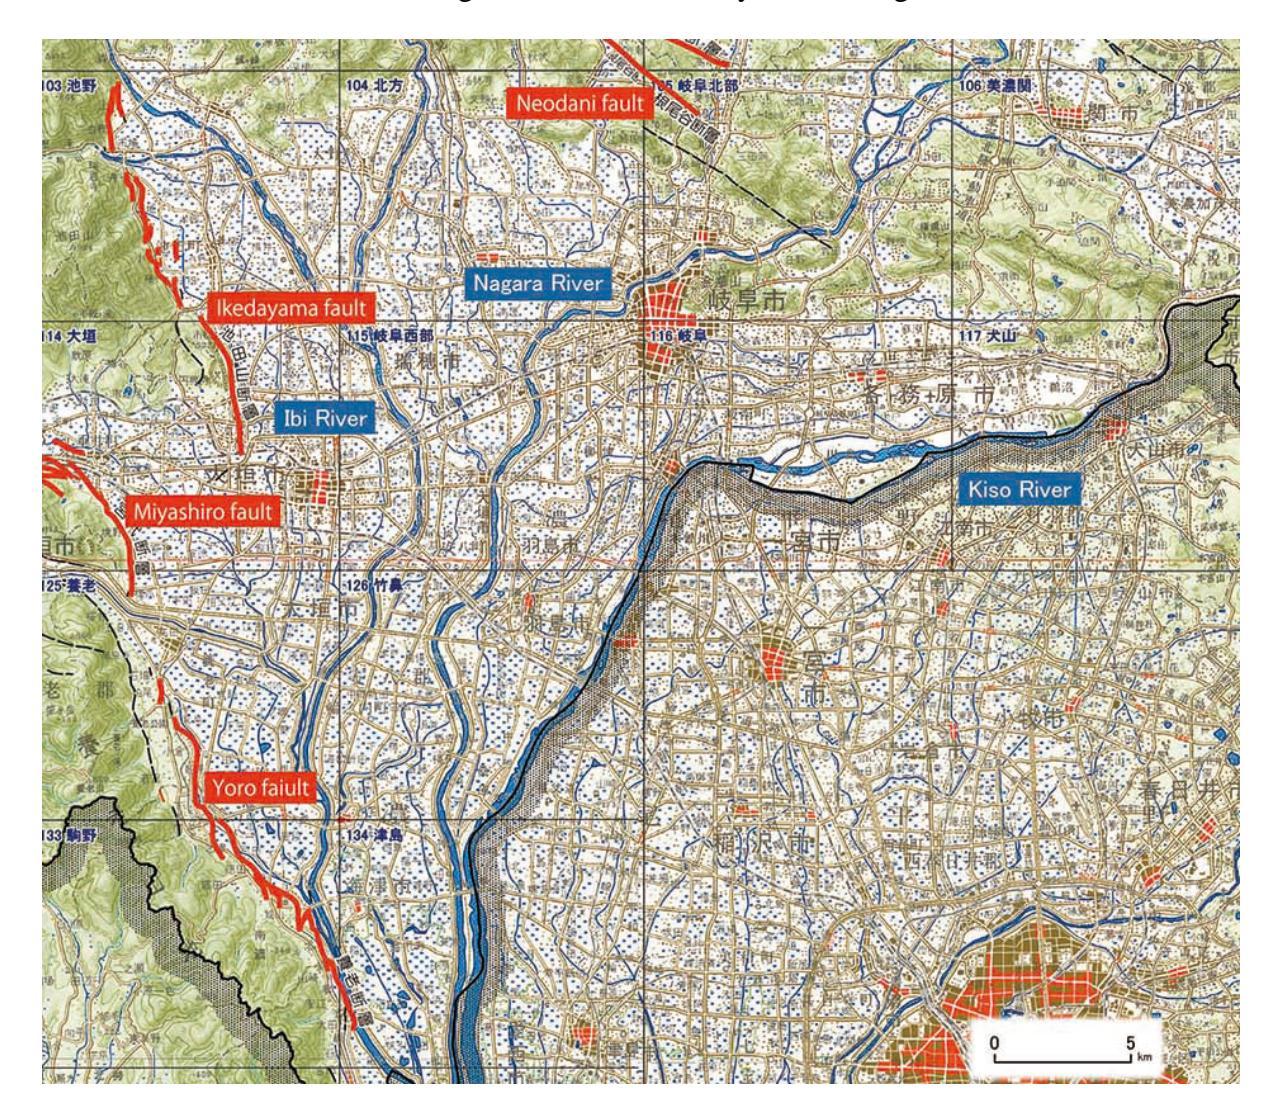
Figure 5. Active fault and Kiso Three Rivers in Nobi Plain.

The Yoro fault is located at the western edge of Nobi Plain. This fault is regarded as one of the active faults related to the Tensho mega-earthquake (1891) as well as to the Tenpyo earthquake (745). This fault runs from north-northwest to south-southeast direction. The Yoro Mountains are located along the west side of Yoro fault, where are still rising. On the other hand, the Nobi Plain is located at the east side of Yoro fault, where is still sinking as shown in Fig.5 (Suzuki,Sugito,2010). The ground deformation of Nobi Plain, which is drawn into the Yoro fault, is called "Nobi tilting movement". It is recognized for the Kiso three rivers to be gathered near the Yoro fault because of the ground deformation by Nobi tilting movement.

Judging from phenomena of (1) Inuyama alluvial fan formed by old Kiso River in the Postglacial, (2) meandering old watercourse before the Tensho river flood, (3) sandbars formed repeatedly in Kawashima area after the river floods and so on, the river inclination was loose and the watercourse was difficult to be fixed in the midstream of Kiso River. Since Yoro – Ise Bay faults had stimulated the ground sedimentation at Nobi Plain by the Tensho mega-earthquake, the southern channel of old Kiso River, which was oriented straight toward Yoro – Ise Bay faults, was assumed to become a dominant watercourse of old Kiso River.
