## Earthquake Vulnerability and the State-of-the-Art of Hybrid Structural Reinforcement and Soil Improvement Methods for Non-Engineered Structures

S. Ortiz-Palacio<sup>1</sup>, S.J. Ibáñez<sup>2</sup>, V. López-Ausín<sup>3</sup>, J.A. Porres<sup>4</sup>

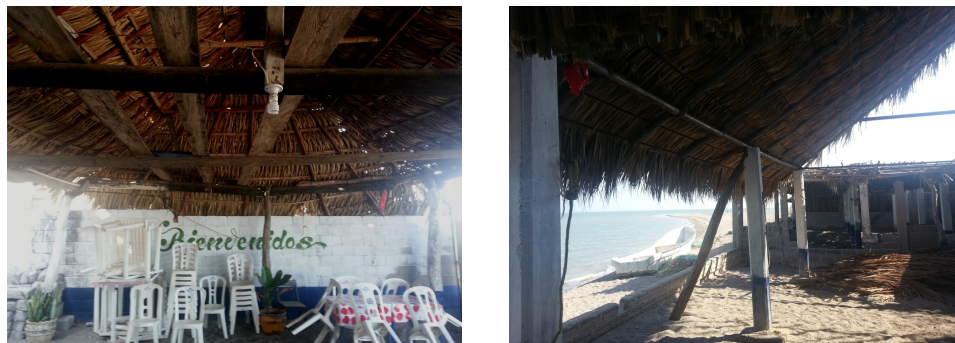
Figure 2. Left: Interior of a timber-roofed building with randomly mixed RC and timber columns and a single unreinforced masonry wall. Right: improvised wooden posts against poorly connected RC columns of the same building (Photos by S. Ortiz-Palacio)

As another example, we may mention the coastal city of Juchitán de Zaragoza, in the State of Oaxaca (Mexico). Although the region is influenced by the subduction boundary of the Cocos and North American plates and its seismic activity is considered to be among the strongest in the country, with frequent earthquakes (BC Consultores, 2012), in Juchitán de Zaragoza these events have more spaced in time. Although historically the city has been struck by some notable seismic events (as the recent 1999 Oaxaca earthquake, Mw 7.5 (Bravo et al., 2004) or the 2008 Unión Hidalgo earthquake, Mw 6.6 (Alvarez-Ramirez et al., 2012), which epicentre was just 50 km far from Juchitán de Zaragoza), many residents confessed little or no concern at all for earthquake hazards when questioned by the authors. As no casualties and seldom structural damage was reported, the seismic hazard is not among the priorities of the residents and, thus, almost none seismic resilient buildings can be found across the city, as the one shown in figure 2, supported by liquefactable sand deposits:
